The Eighteenth Spencer Buchanan Lecture
Friday December 3, 2010
College Station Hilton
College Station, Texas, USA
<http://ceprofs.tamu.edu/briaud/buchanan.htm>

Uncertain Geotechnical
Truth and Cost Effective
High-Rise Foundation
Design

The 2009 Karl Terzaghi Lecture
By Mr. Clyde Baker

Forensic Diagnosis for
Site-Specific Ground
Conditions in Deep
Excavations of Subway
Constructions

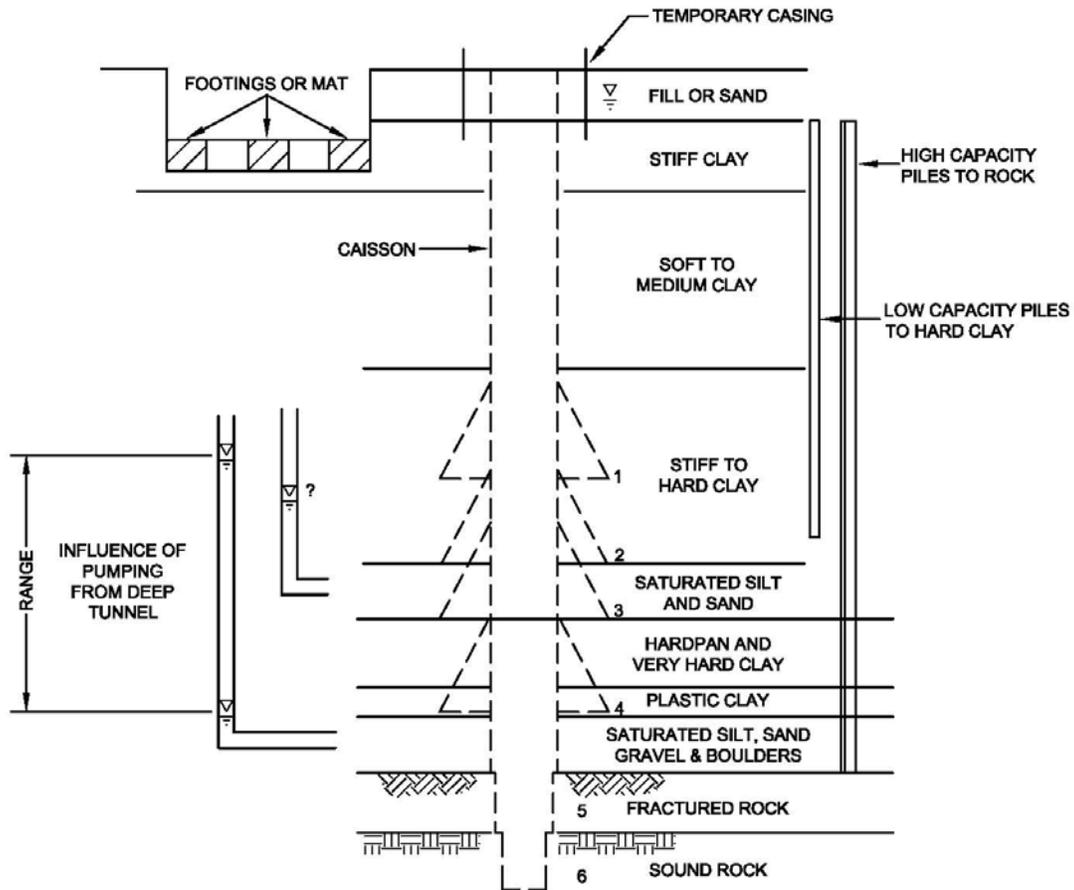
FIG. 1. Typical Soil Profile and Potential Foundations for Downtown Chicago

A typical soil profile for downtown Chicago is shown in Figure 1, with the various foundation types that have been used in Chicago. Prior to approximately 1883, most of the downtown Chicago structures were in the three to six-story height range, and were supported on footing foundations. In the 1890's taller buildings, up to 20 stories in height, such as the Monadnock Building and the Auditorium Building, were constructed on footing and mat foundations supported on the stiff clay crust which is encountered above the soft clay deposits.

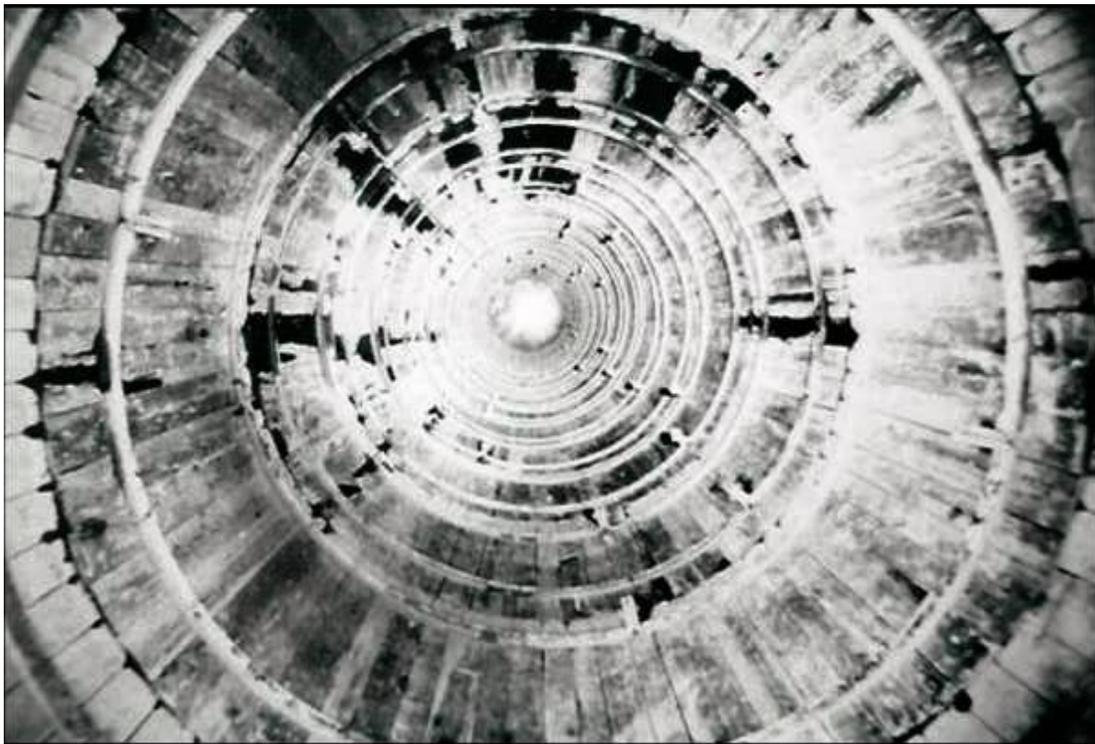
FIG. 2. Chicago City Hall caisson, circa 1910

The Chicago caisson was developed in 1894 by General Sooy Smith to avoid the vibration problems inherent in the pile driving techniques of that time. The method involved hand digging a circular shaft with side walls maintained open by vertical lagging and steel circumferential rings. At first, the Chicago caisson method was used for underpinning or support of only part of the structure adjacent to existing buildings. Eventually consistency in the construction improved, and by approximately 1899, hand-dug caisson foundations were used under entire buildings. Figures 2 and 3 show as open, ringed and lagged straight shaft caisson at the City Hall Building, circa 1910, and workers manually digging a large diameter shaft at the Daily News Building, circa 1927. The role of the business-suited observers in Figure 3 is unknown but might be the design architect and engineer.

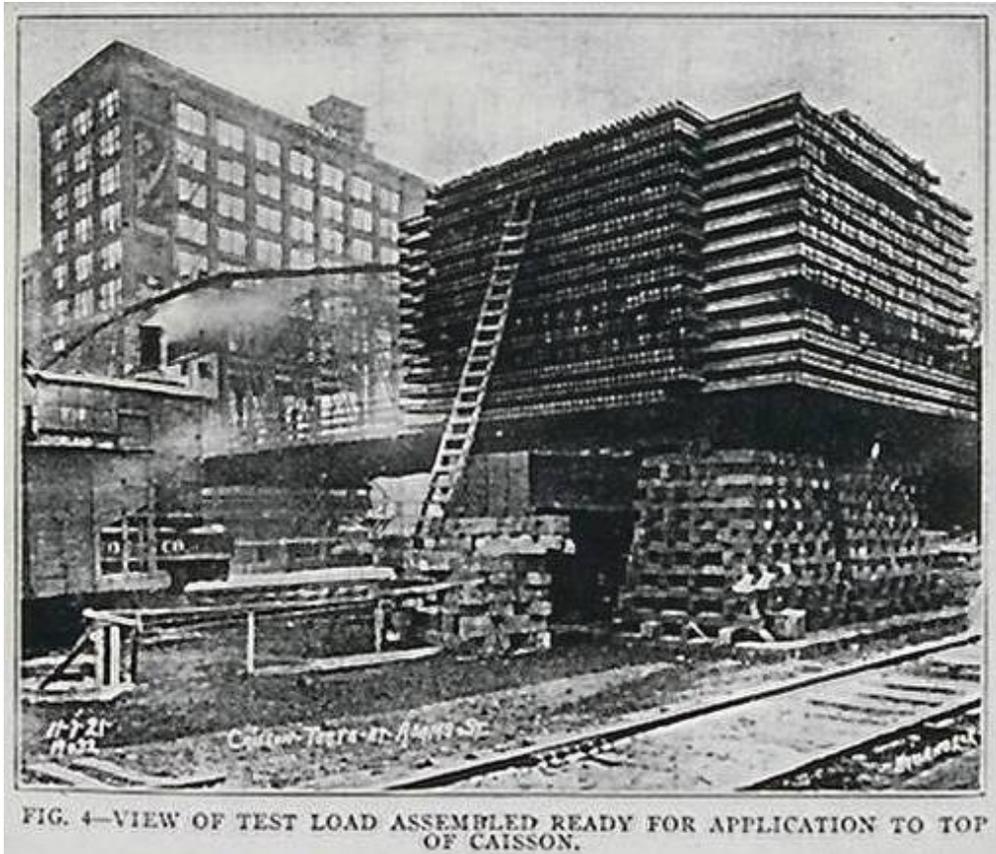
FIG. 4. View of test load assembled ready for application to top of caisson

D'Esposito performed the full scale load test program to confirm design assumptions and determine ultimate capacities. Figures 4 and 5 show this load test and the impressive results. Even though this was before the advent of modern soil mechanics, the engineers recognized that part of the test load was being carried by friction in the softer soils above the bearing stratum.

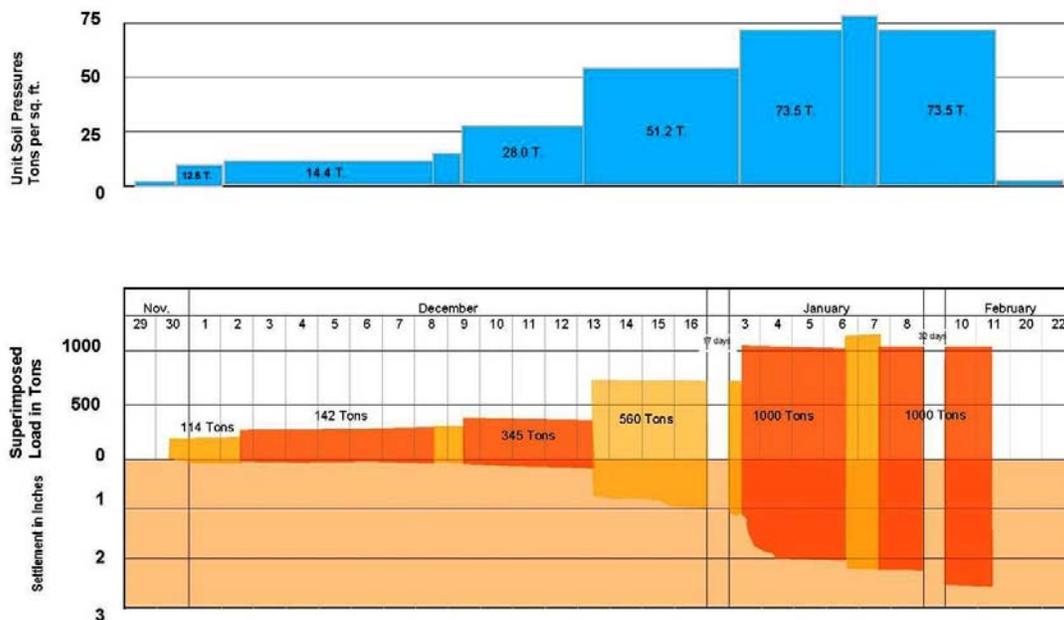
FIG. 5. Union Station caisson load test results

In a second test, a tunnel was advanced in the hardpan underneath the caisson shaft to remove any end bearing capability. The shaft was then reloaded to determine the side friction. The mobilized bearing resistance capacity of the hardpan was calculated to be more than 6.2 MPa (65 tsf), or more than 10 times the allowable bearing pressure they were trying to confirm. As remarkable as the results were, the preference for the use of caissons to rock at the time delayed widespread use of belled caissons bearing in hardpan.

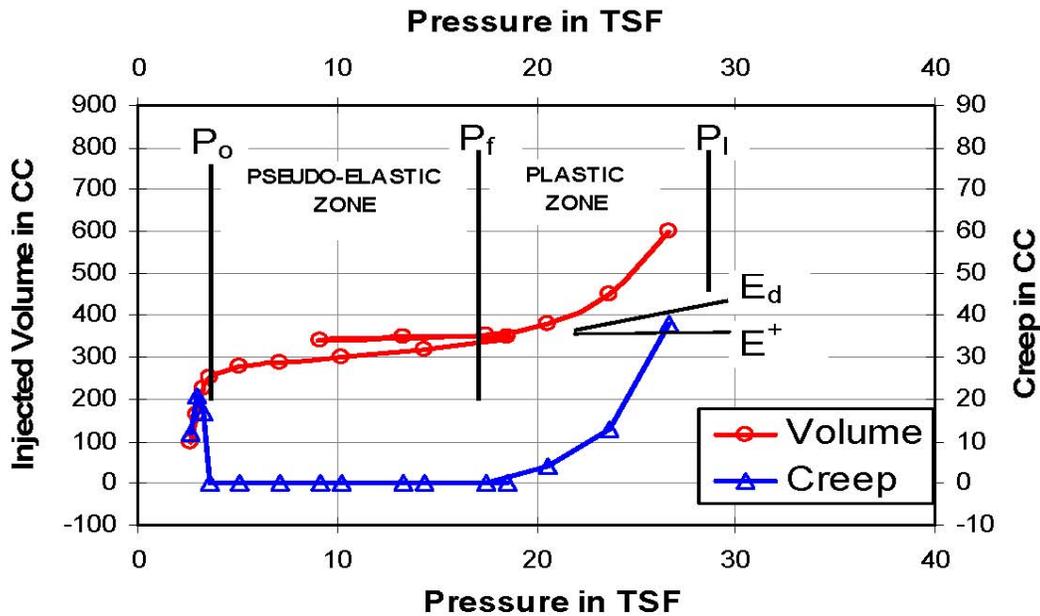
FIG.6. Pressuremeter Data Reduction Outcomes

For this reason, when running the pressuremeter test, the author recommends running an unload/reload cycle between a point slightly below the creep pressure P_f to a level slightly above P_o , the in-situ horizontal earth pressure as shown in Figure 6.

E_d = Deformation Modulus
 E_o = Rebound Modulus
 E^+ = Recompression Modulus
 P_f = Creep Limit
 P_l = Limit Pressure
 $\alpha = E_d/E^+$

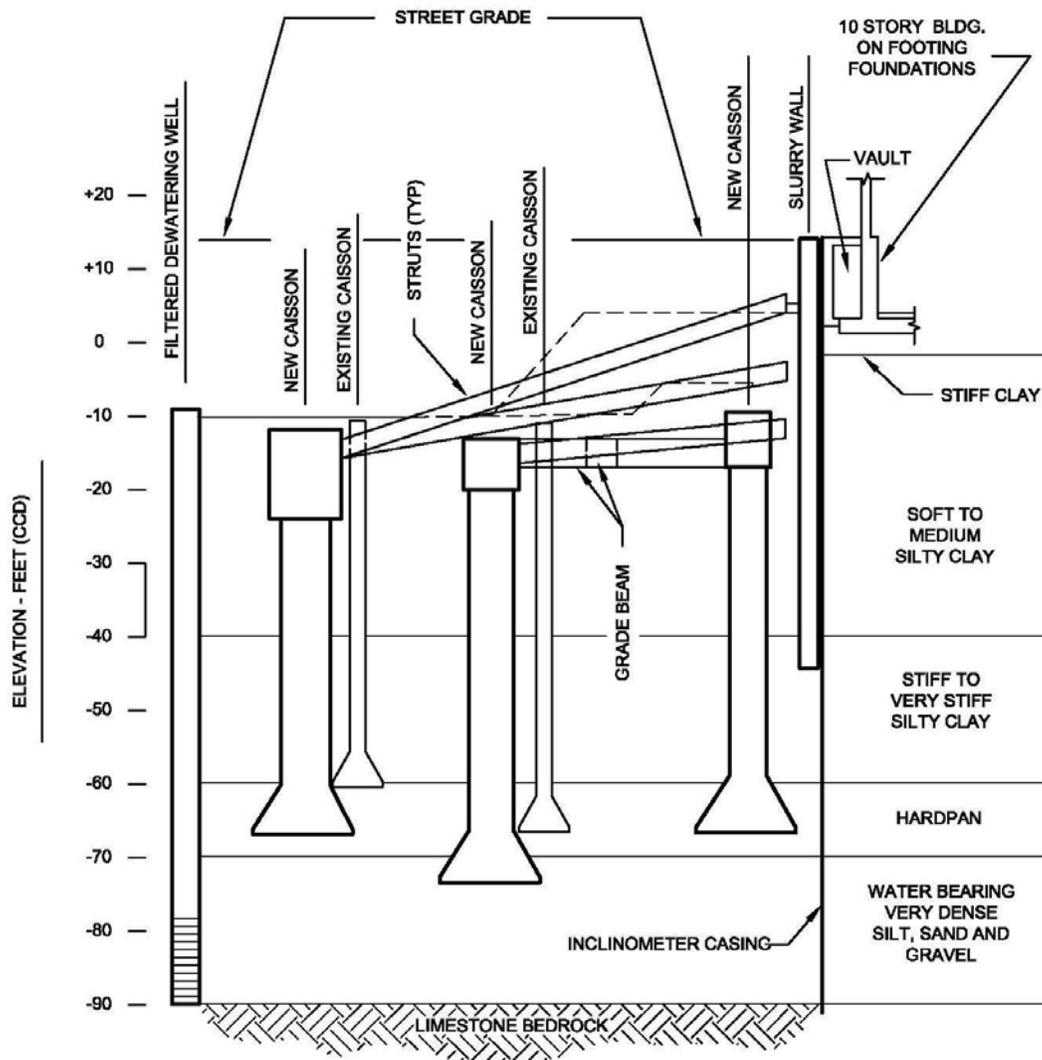
FIG. 7. AT&T Corporate Center Substructure Profile

AT&T was the first building in Chicago to utilize a bearing pressure of more than 1.9 MPa (40 ksf) on the Chicago hardpan. The foundation engineering for this project was described in a presentation to the Foundation Engineering Congress held in Chicago in 1989 (Baker *et al*, 1989). The project was complicated by the presence of existing caissons and an adjacent 10-story building supported on footing foundations above the Chicago soft clay. A logical but expensive solution was to support the tower on rock caissons. Rock caissons were priced at three times the cost of belled hardpan caissons. Because of the presence of the existing caissons it was necessary to extend the very heavily loaded new caissons, about 14,000 kips (7000 t), that would support the building core, through the hardpan and into a very dense water-bearing silt, sand and gravel, as shown in Figure 7.

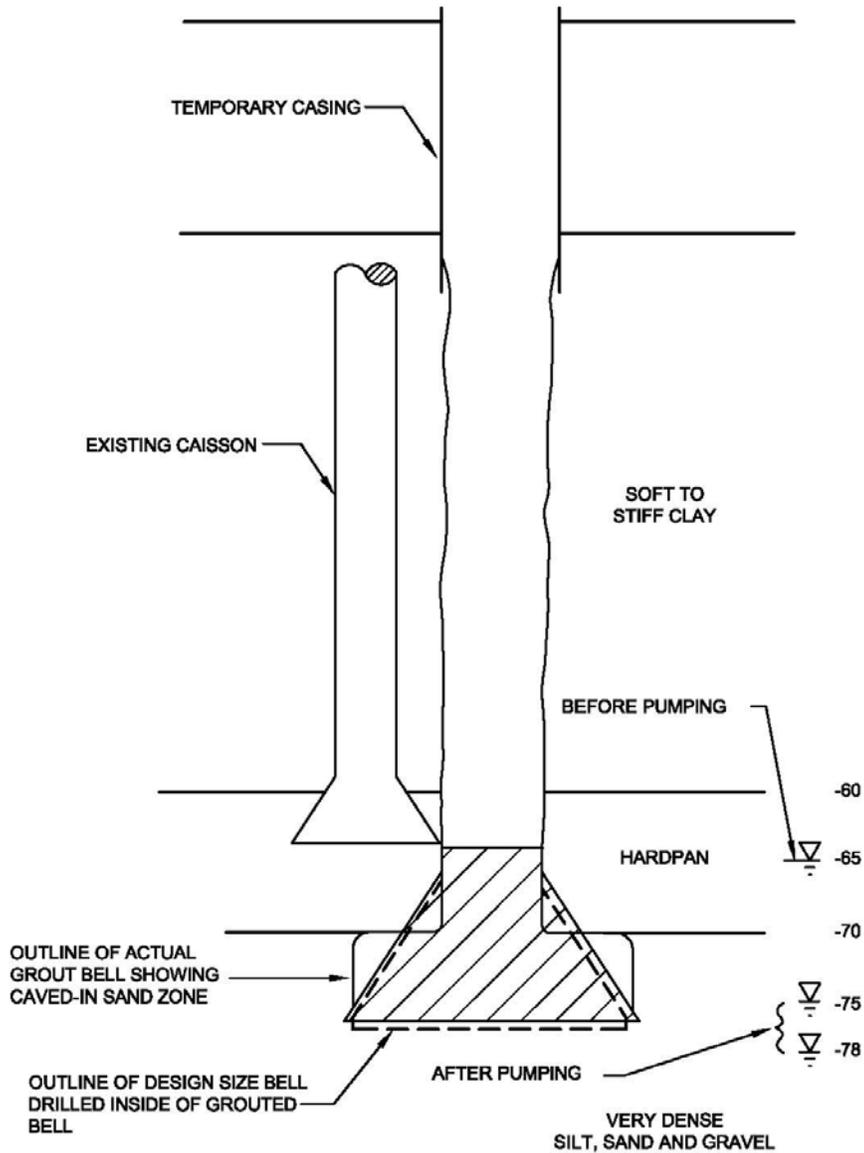
FIG. 8. AT&T “Grouted Bell” Method of Caisson Construction in Caving Soil

Pressuremeter testing indicated that 2.25 MPa (45 ksf) bearing could be used in the hardpan and as much as 2.4 MPa (50 ksf) bearing could be used in the underlying very dense silt, sand and gravel if bells could be constructed. This required the use of filtered dewatering wells to lower the water table so that the bells could be constructed. However, it was not known whether the excavated bell walls would remain stable in the silty sand and gravel even when dewatered. A contingency plan was developed as shown in Figure 8 which involved constructing an oversized bell that would be filled with low-strength grout so that a design sized bell could be constructed within the grout bell the next day. This approach had been used successfully on other projects when bell excavations penetrated water-bearing sand (Baker *et al*, 1989). The owner's representative was made aware of this contingency plan and the potential costs. Fortunately for this project, the surface tension developed by dewatering provided enough apparent cohesion to the very dense silt, sand and gravel to keep it stable during bell excavation.

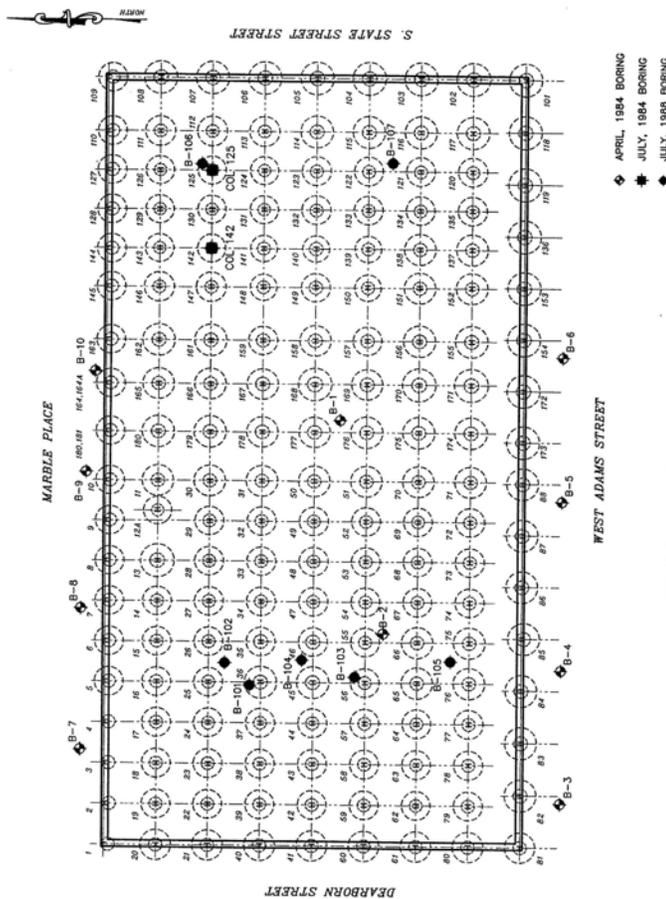
FIG. 9. Dearborn Center Caisson Foundation Plan

performed from the existing lowest basement elevation at -23 ft. Chicago City Datum (CCD) with two borings performed at the first basement level at elevation -4 ft. CCD. A location plan showing all borings, as well as the existing caissons, is included as Figure 9. Borings were performed adjacent to existing Columns 36, 56 and 125 to confirm the presence of the bells and to access the soil immediately below the bells for testing. These borings were advanced to the top of the caisson bell, which was cored with diamond-bit tools to confirm concrete integrity. Coring of the shafts was not considered necessary, since experience has indicated that the poorest concrete is usually found in the bells, as it does not get the same compaction and consolidation effect as the shaft concrete. These three borings were then extended below the bottom of the caisson bell to elevations ranging from -79 to -85 ft. CCD. Pressuremeter tests were performed below the caisson bell in all three of these borings.

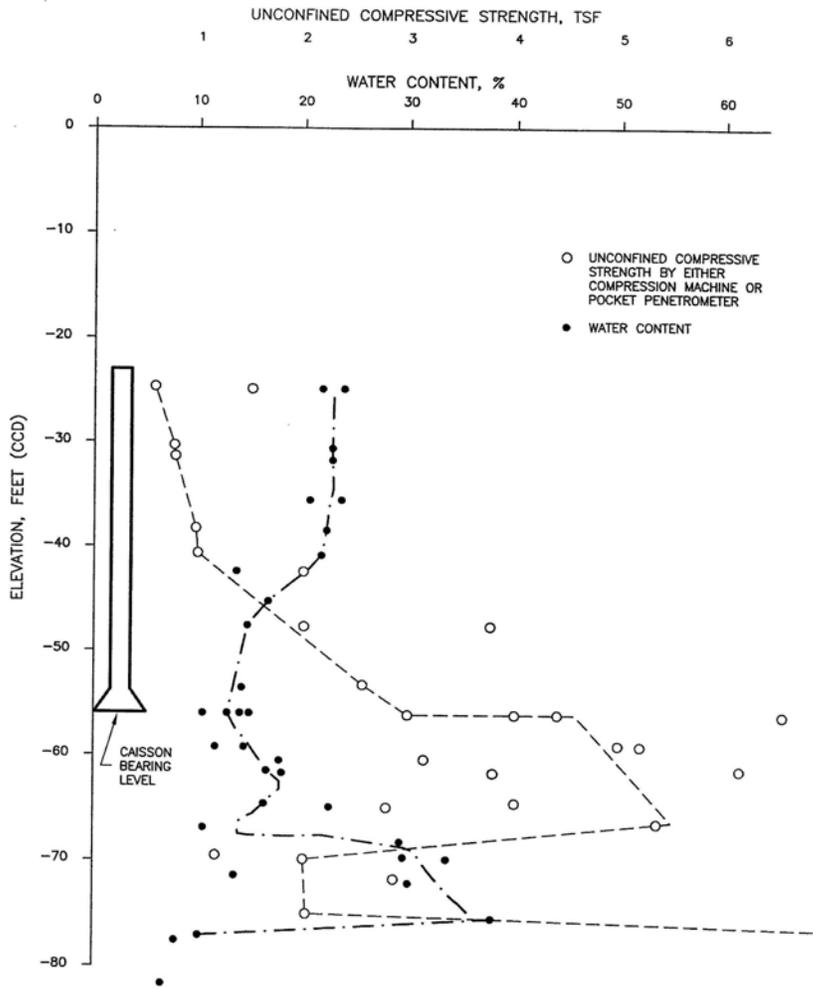
FIG. 10. Dearborn Center Unconfined Compressive Strength and Water Content Evaluation

A typical soil profile and a graphical plot of the key pressuremeter test results are shown on Figure 10 and 11. A complete tabulation of pressuremeter test results was presented at the 5th International Conference on Case Histories (Baker *et al*, 2004a).

The pressuremeter tests indicated an average creep pressure of approximately 862 kPa (18 ksf) in the very stiff to hard silty clay zone beneath the caissons. The drop-off in unconfined compressive strength and increase in water content noted in the zone from -68 to -75 ft. CCD (Figure 10) did not result in significantly reduced modulus or creep pressure value, indicating a fairly consistent preconsolidation pressure. It is likely that the higher water content indicates greater plasticity and moisture retention under comparable loads. In order for the settlement to be within the pseudo-elastic zone, the dead load and long-term live load bearing stress plus the overburden pressure should not exceed the average creep pressure. Thus, allowing for an existing overburden pressure of approximately 192 kPa (4 ksf) relative to top of mat level, the maximum dead load pressure could not exceed 670 kPa (14 ksf) to keep the combined

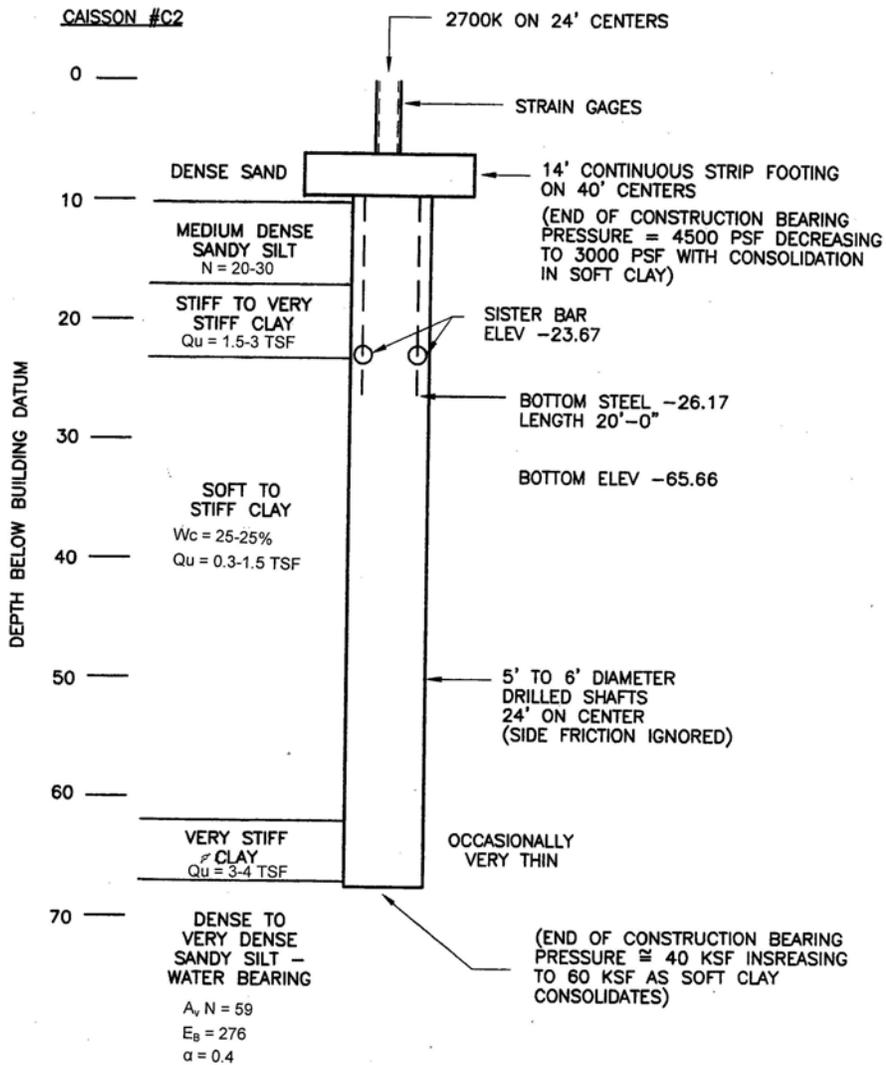
FIG. 12. 12-Story Parking Garage and Office Combined Strip Footing Drilled Shaft Interaction Instrumentation

Because of the potential for squeezing of soft clays and the relative thinness of an adequate bearing layer at depth, a preliminary geotechnical report declared construction of conventional belled caissons for this project to be too risky and expensive. The author's firm was retained to further evaluate a shallow foundation solution and provide cost effective methods for reducing the anticipated settlement. A supplementary field exploration program was performed consisting of five (5) borings, including in-situ pressuremeter tests conducted within the upper sands just below anticipated footing level, pressuremeter testing within the lower silty sands just below potential deep caisson bearing level, in-situ vane shear testing within the soft clay below footing level and selective, undisturbed three-inch diameter piston sampling of soft clay for consolidation testing, as well as shallow and deep water table measurements. The soil profile, together with the final instrumented foundation system selected is shown in Figure 12.

In order to determine how load actually is distributed between the shafts and the strip footing, strain gages were placed in two representative shafts and first floor columns as shown on Figure 12.

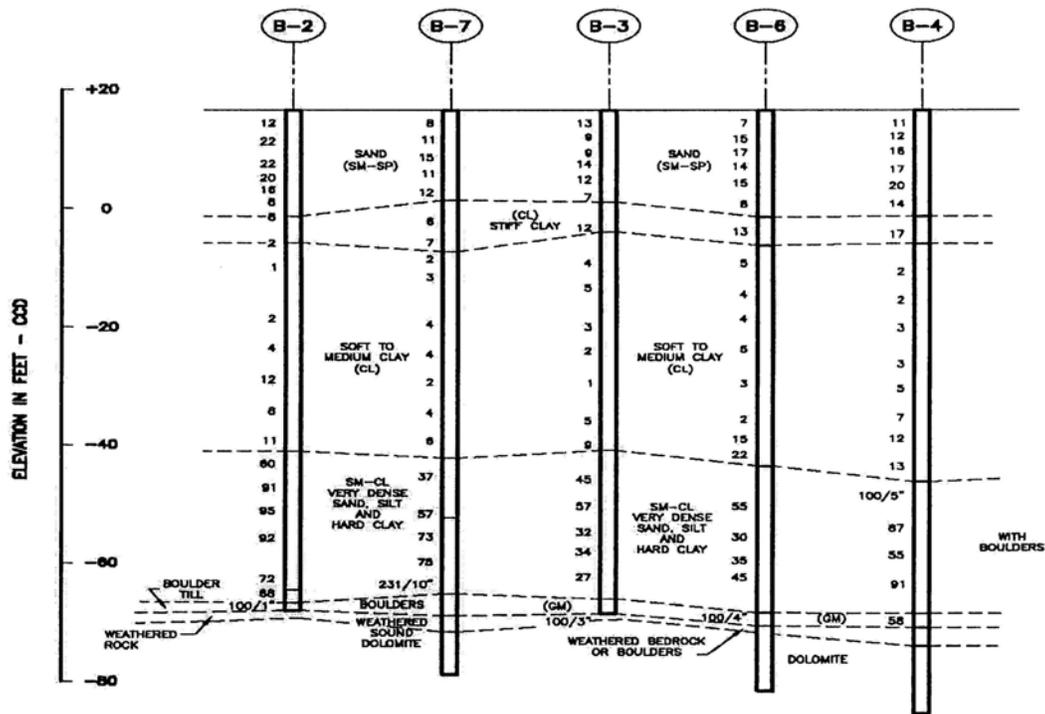
FIG. 13. Soil Profile

It is necessary to remember that “things are not always what they seem,” and “we don’t always know as much as we think we do”. This case history illustrates some of the points made earlier and the results that happened when these points were not borne in mind. This case history concerns a 19-story high rise residential building, comprised of five levels of parking and 14 levels of condominiums, located just south of the Loop in Chicago. The original foundation design consisted of rock socketed and steel cased caissons into sound dolomite. The contractor proposed a value engineering option that consisted of straight shaft caissons, constructed under polymer slurry without casing, to the top of rock, and designed for 100 ksf bearing. The soil profile is shown in Figure 13. It indicates surface sand to a depth on the order of 15 feet (4.6 m), underlain by a thin stiff clay crust, followed by soft to stiff clay, down to a very stiff to hard silty clay till, which extended to a thin boulder till just above the dolomite.

The borings performed around the perimeter of the site indicated fairly flat lying soil and rock deposits.

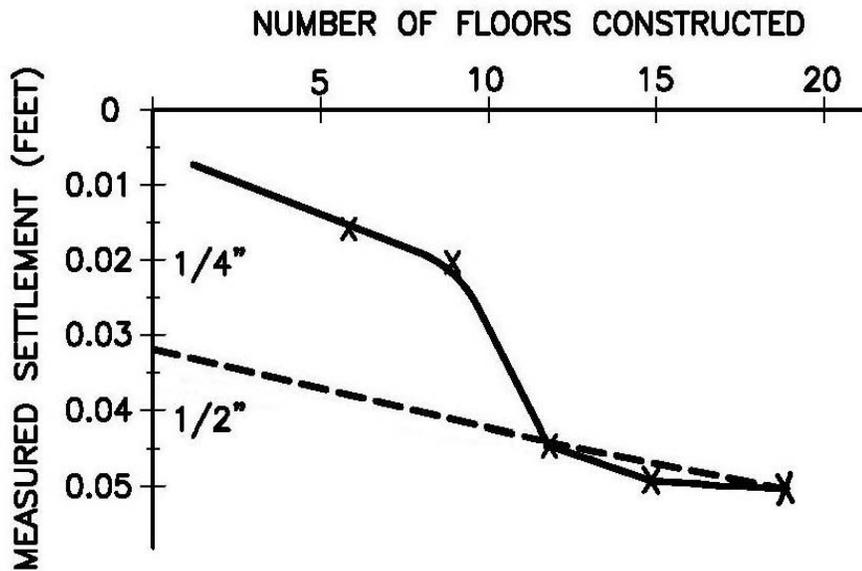
FIG. 14. Average Building Settlement Versus Number of Floors Constructed

With all of this data, a spring model was developed for the structure and settlement of the as-constructed caissons was predicted. The main concern was the differential settlement between those caissons that did get to rock and those caissons sitting on the boulder till. The structural engineer had set 10 mm (0.4 in) as the maximum differential settlement tolerable, and the developed spring model indicated that settlements would be less than this, except at one possible location which was marginal. This particular caisson was supplemented with three micropiles. The building was then constructed, and settlement measurements were recorded. The results are shown in Figure 14.

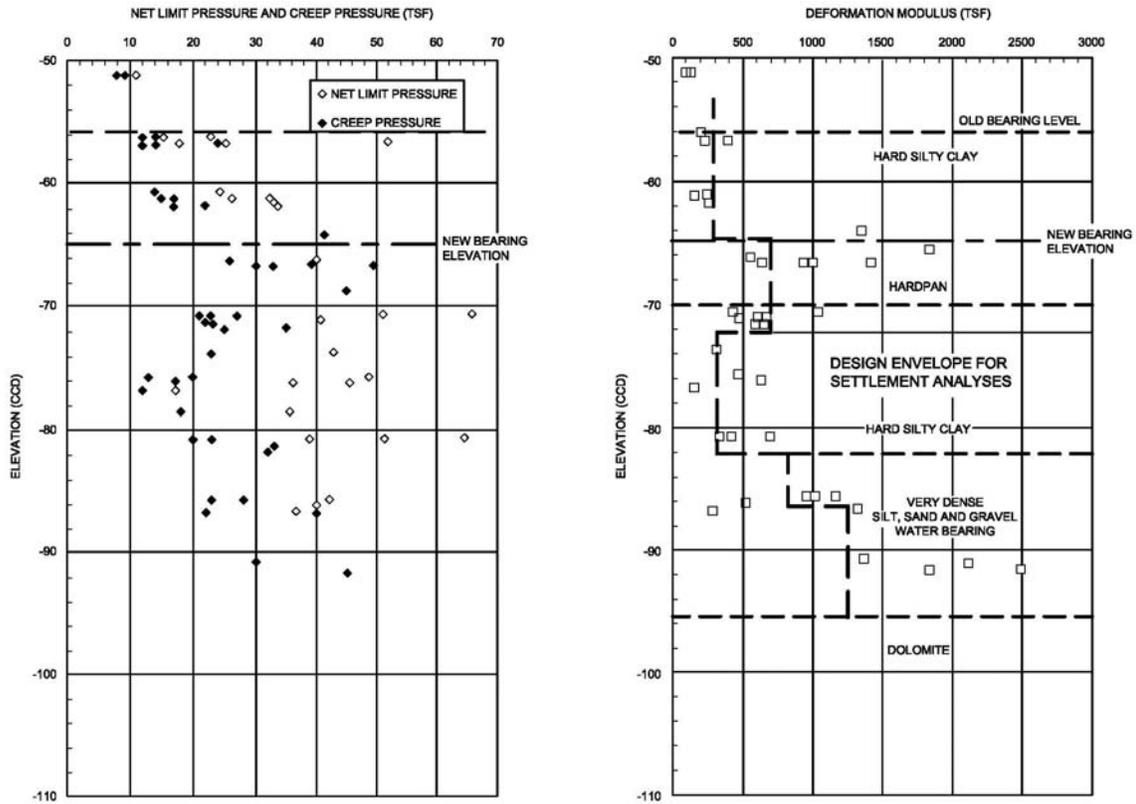
FIG. 15. Pressuremeter Test Profile

The PMT tests indicated that the bearing pressure under the existing USG caissons could safely be increased from 766 to 1,150 kPa (16 to 24 ksf), and that the new caissons, founded in the Chicago hardpan at elevation -65 ft CCD, could be designed for a net allowable bearing pressure of 2,155 (45 ksf). The net limit pressure, creep pressure, and interpolated modulus data are plotted versus elevation in Figure 15. The units are shown in tsf, which is roughly equivalent to kg/cm^2 . The bearing elevation for the new caissons is indicated by the dashed line. The typical design envelope for settlement calculations is depicted on the deformation modulus plot.

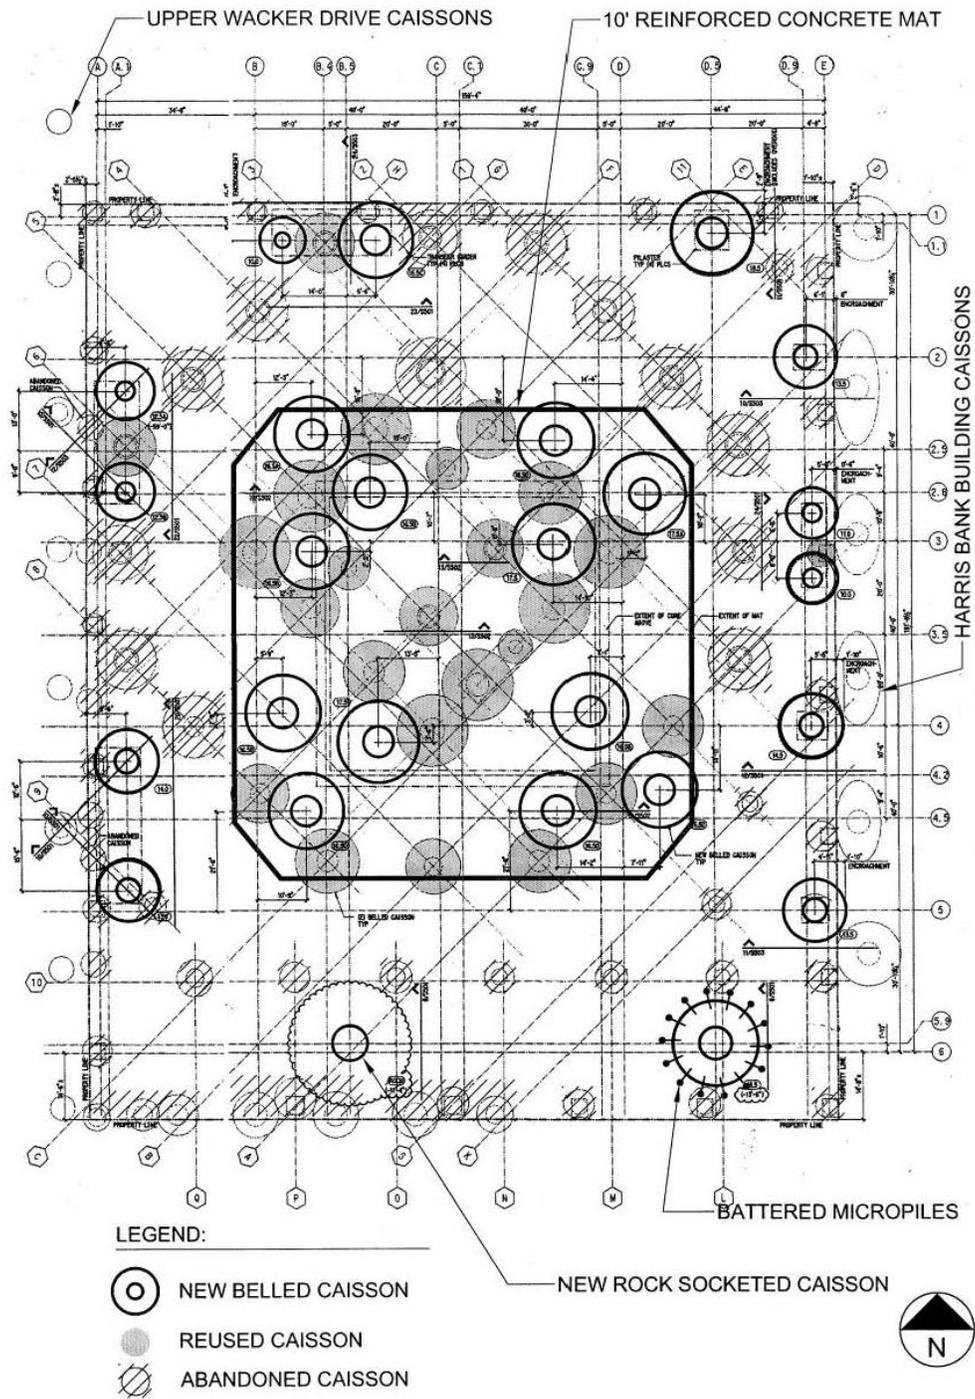
FIG. 16. Foundation Plan for 111 South Wacker Drive

As shown in Figure 16, the reinforced concrete building core is supported on an approximately 30.5 m (100-ft) square mat, by 12 new large-diameter belled caissons and 22 existing USG caissons. Because of the unique building architecture, the perimeter building loads for the entire 51-story structure are transferred to the foundation by two exterior columns on the sides facing Monroe Street to the north, the public alley to the south and South Wacker Drive to the west. These non-redundant columns are supported by either a single new caisson, or a combination of reused and new caissons connected with grade beams.

Unanticipated water problems were encountered at two caissons, D.5-5A and B.5-5A. The corrective measures used are described in detail in the reference paper. Caisson D.5-5A was supplemented with 14 rock socketed micropiles because of excessive water seepage and concern about completed bell bottom softening. Caisson B.5-5A was re-drilled as a steel-cased rock socketed caisson, as bell construction was not possible due to excess water inflow and cave-in.

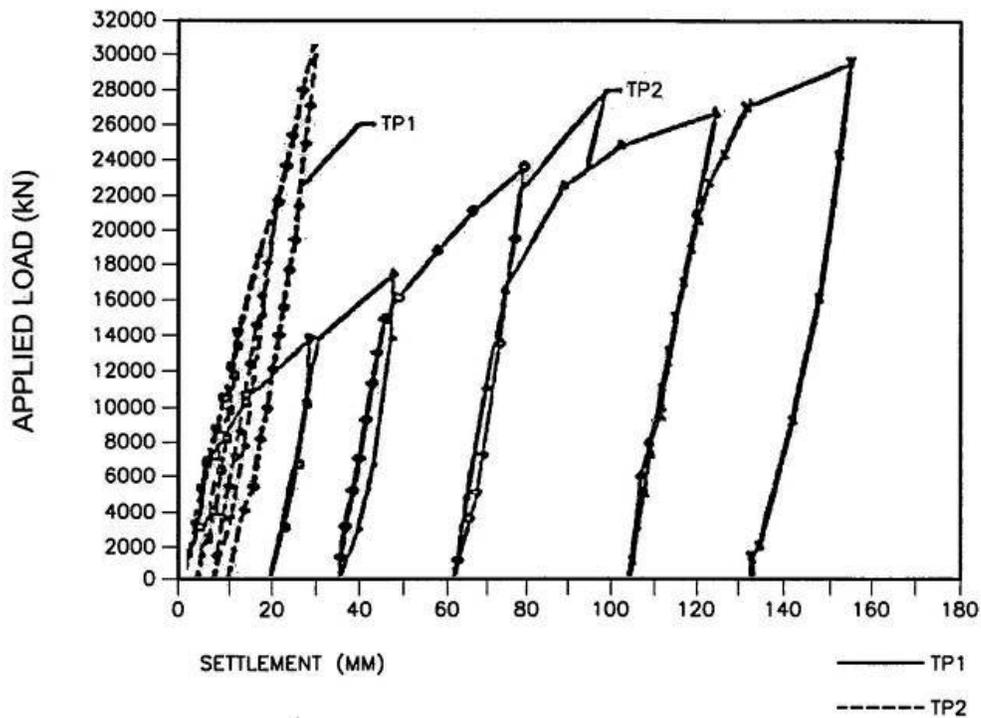
FIG. 19. Applied Load vs Settlement Test Pile 1 and Test Pile 2

APPLIED LOAD vs SETTLEMENT
TEST PILE 1 AND TEST PILE 2

Kentledge load tests were performed, using house-high blocks of concrete to provide the reaction. The results of the load tests are shown in Figure 19. Both test piles were 75 meters (245 feet) long and constructed under bentonite slurry. One test pile was post-grouted to break through any filter cake development. Further details are in the reference papers. The post-grouted pile could not be failed with a maximum developed side friction of 330 kPa (6.86 ksf). This led to a recommended design value of 110 kPa (2.28 ksf), and a requirement that all piles be similarly post-grouted.

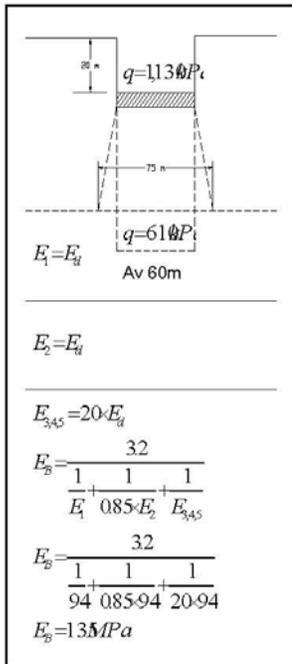
FIG. 20. Equivalent Footing Method for Settlement Calculation, Petronas Towers

Pressuremeter Data

$$E_{d,Av} = 94.3 \text{ MPa}$$

$$S = 59 \text{ mm} + 14.4 \text{ mm} = 73.4 \text{ mm}$$

Settlement analyses were performed, using the equivalent footing method and simple hand calculations, as shown on Figure 20. Extensive settlement analyses were also performed, utilizing the SAP 90 program and the Plaxis 3-D program, using soil modulus estimates based on back calculation from the test pile program, and from averaging the reload modulus slopes of the in-situ pressuremeter tests. Pile lengths were varied until calculated maximum differential settlement goals were achieved.

Calculated average settlement, from the equivalent footing method and average uniform conditions, ranged from 41 mm (1.6 in) using the Ménard rules, to 73 mm (2.9 in) using elastic theory. This brackets the computer-generated values, using actual pile length and rock slope geometry.

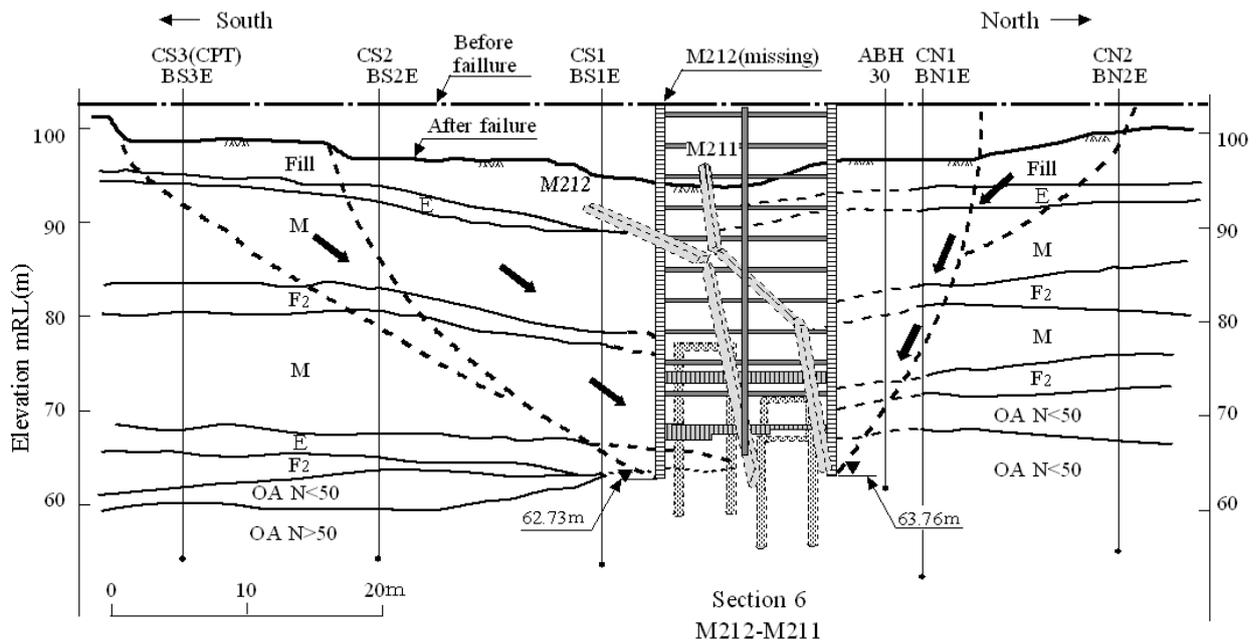
Figure 13. Features of the ground movements towards the excavated space accompanies by the subsidence

Note: All shapes of diaphragm walls underground are unverified assumption

This scenario of the event was substantiated by the borings conducted after the failure in which the elevation of the intermediate layer F_2 was found to be located almost 10m lower than that found by the borings before the failure. Note that prior to the collapse, the elevation of the base of intermediate F_2 layer was remarkably consistent across the collapse area, and so provides a good marker for identifying the vertical displacement of the soil deposit. The location of the F_2 layers after the collapse is shown in the cross-section in Figure 11. It was then possible to depict the mode of soil movement involved in the slides on the south and north sides. The approximate locations of the sliding surfaces are displayed in Figure 13 for the cross section 6-6 of Figure 12.

part of the OA layer, as inferred from the settlements of the upper lying layer F₂, as shown in Figures 13 and 15, which was confirmed by the post collapse boring data. From the records of the diaphragm wall construction, the bottom line of the wall before the collapse is known and it is shown together in Figure 17.

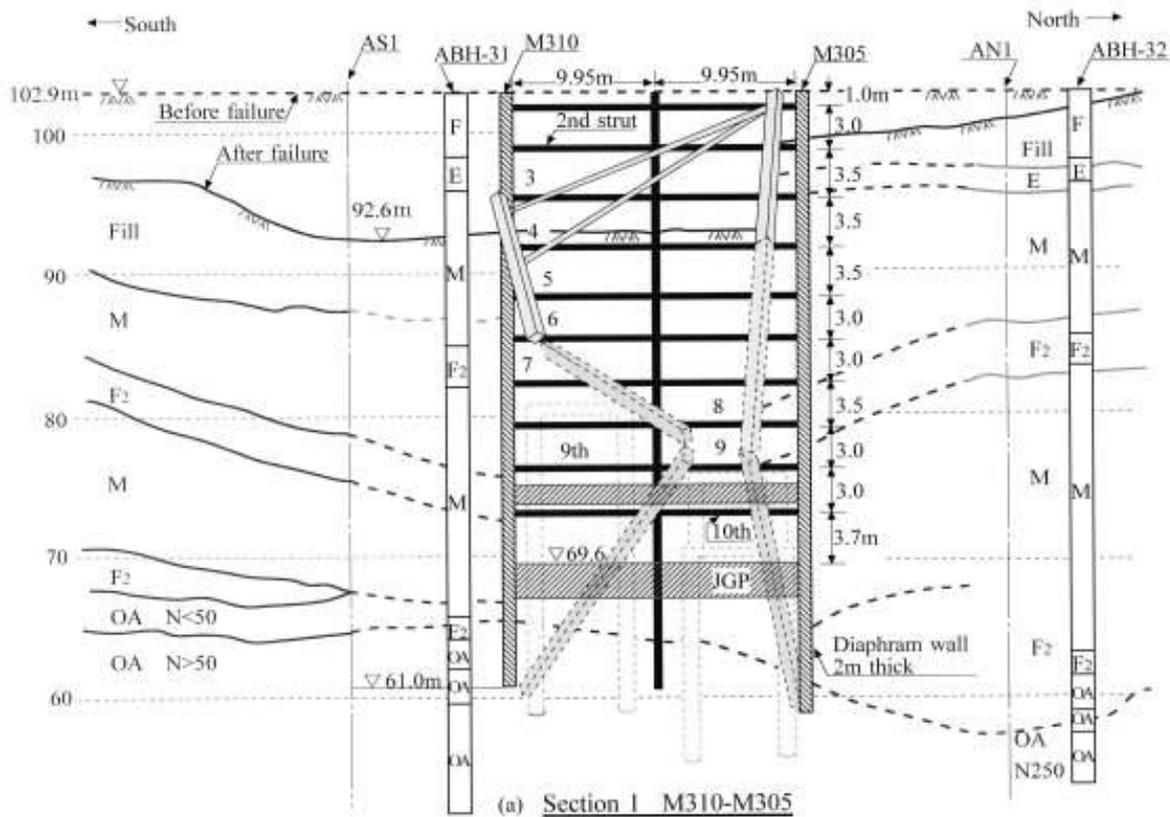
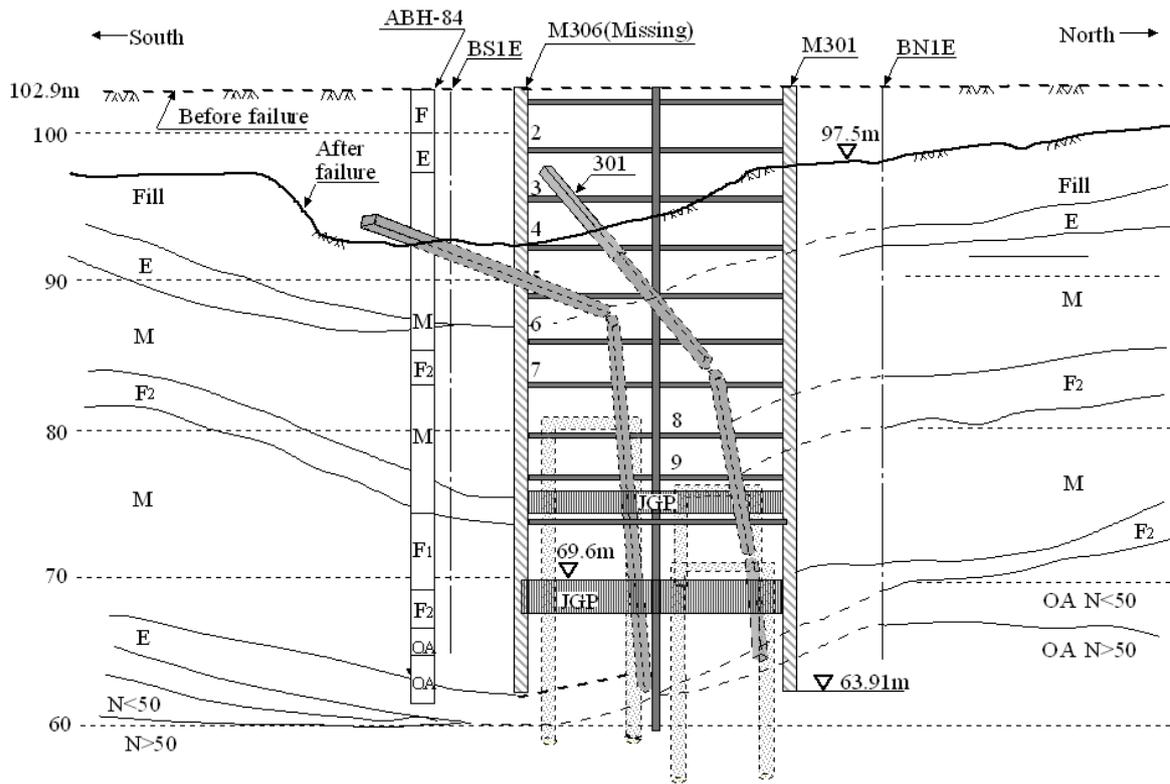
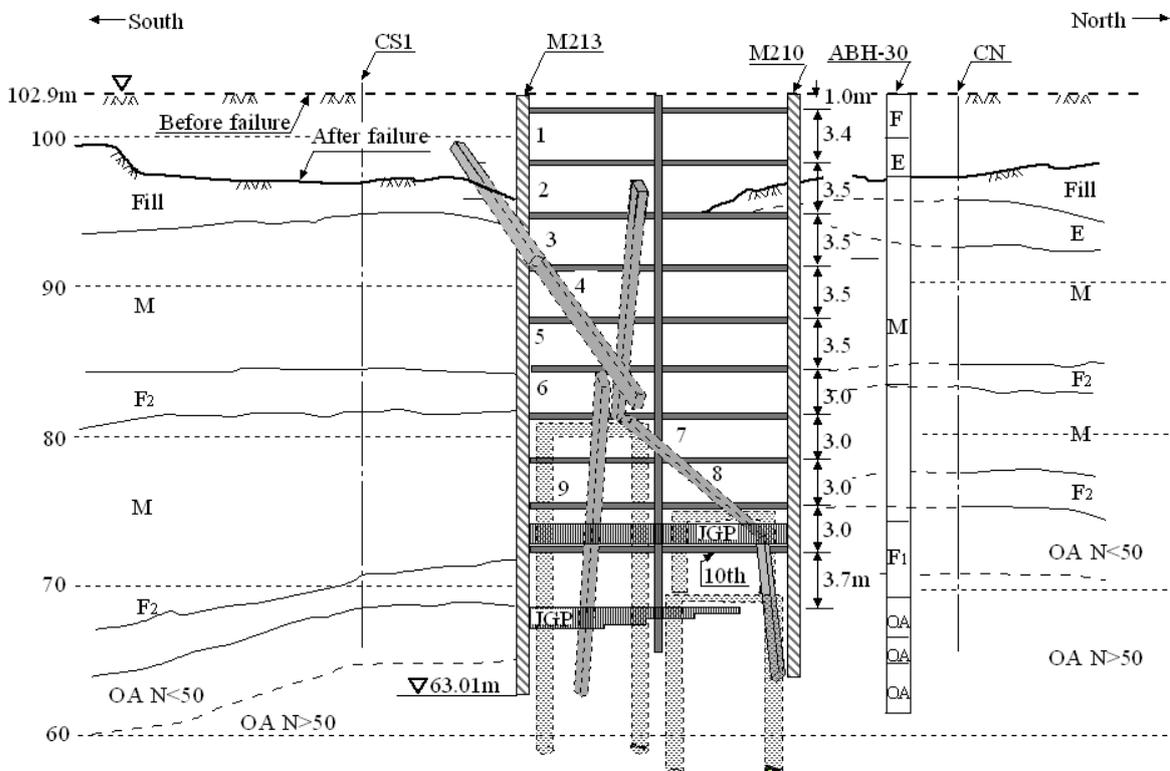
Figure 15. Cross sections showing the mode of collapse in the zone of failure

Note: All shapes of diaphragm walls underground are unverified assumption

(b) Section 5 M306-M301

(c) Section 7 M213-M210

As a result of the post-incident in-situ investigations as above, it became possible to figure out approximately the states of collapse to each of the cross sections indicated in Figure 14. Shown in Figure 15 are probable features of the collapsed waler-strut system buried within the ground which were speculated for the cross section 1, 5 and 7. It is to be noticed that in the cross section 1 and 5, the inter-mediate layer F_2 is inclined towards the excavation as verified by the boring data at ABH31 and 32 and also at AS1 and AN1 conducted after the failure. This is indicative of the settlement of the even deep-seated soil layer involved in the slide.

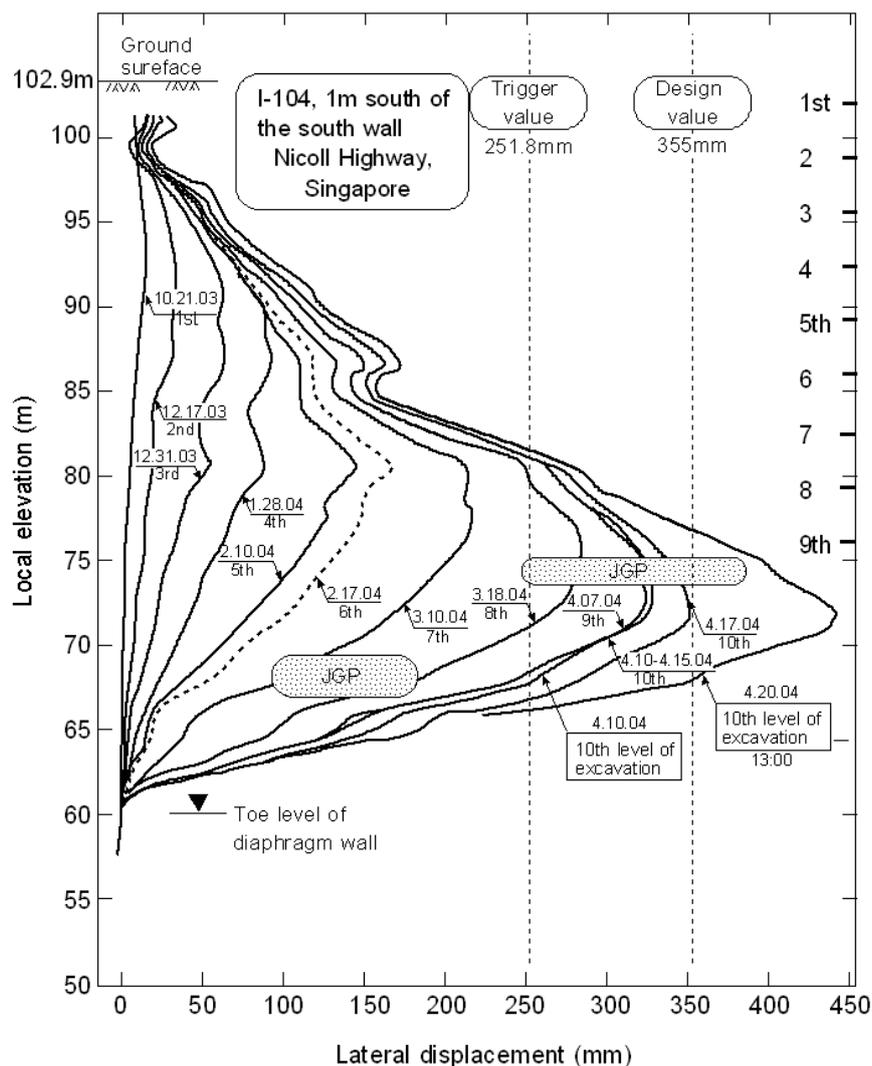
Figure 19 Time change of depthwise distribution of the wall measured by the inclinometer in the soil deposit 1m apart from the south wall

In the area which failed there were inclinometers at or just behind the wall at the north and south sides of the excavation. Shown in Figure 19 is the time change of depthwise distributions of the wall deflection estimated from the inclinometer, I-104, which had been installed in the soils 1.0m apart from the south wall near M212 (Fig. 18). It is known that the wall deflection started to increase significantly from April 17, 2004 as indicated by a dash line in the figure. The maximum displacement measured at 13:12 on April 2004 is known to have amounted to 43.5cm at the elevation of 72m. It is to be noticed that actual collapse took place at 15:33. i.e. 2 hours 21 minutes (141 minutes) afterwards. Thus, it is likely that just at the time of collapse, the maximum value of the wall deflection might have been larger than 43.5cm. It should be cautioned that the waler-strut system had sustained the deflection of at least 43.5cm for the period of 141 minutes without causing collapse.
