The Eighteenth Spencer Buchanan Lecture
Friday December 3, 2010
College Station Hilton
College Station, Texas, USA
<http://ceprofs.tamu.edu/briaud/buchanan.htm>

Uncertain Geotechnical
Truth and Cost Effective
High-Rise Foundation
Design

The 2009 Karl Terzaghi Lecture
By Mr. Clyde Baker

Forensic Diagnosis for
Site-Specific Ground
Conditions in Deep
Excavations of Subway
Constructions

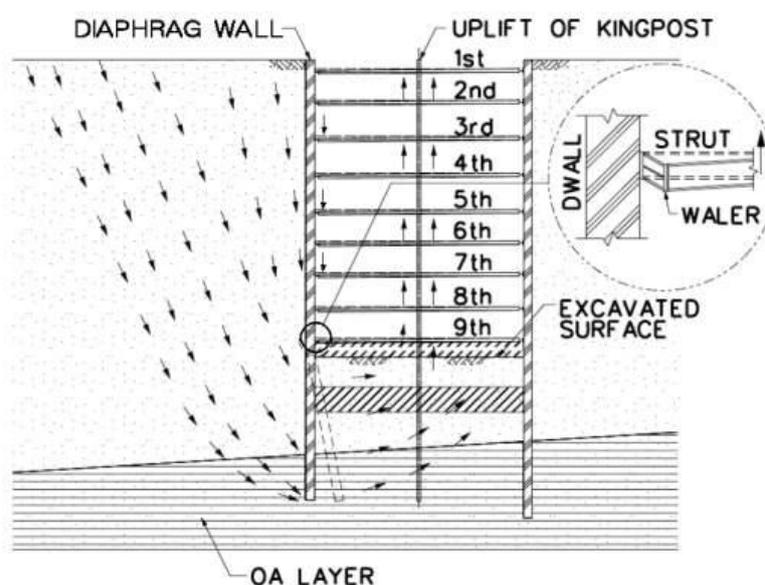
Figure 20. Probable movements of soils near the toe of the diaphragm wall, and uplifting of the kingpost and sag of the wall leading to buckling and offset between strut and waler

- (3) This uplift, combined with the sag of the wall must have caused the local buckling or breakage of the flange of the H-beams at connection between the walers and struts, creating as much as 20cm vertical offset as illustrated in Figure 20. As a result, the net length of the struts was shortened and diaphragm wall must have deformed further inwards.

- (5) With the loss of functioning of the waler-strut system and increased inward movement of the wall panel toe, the integrity of the structural support as a whole was completely lost, leading eventually to the total collapse. This is illustrated in Figure 20.

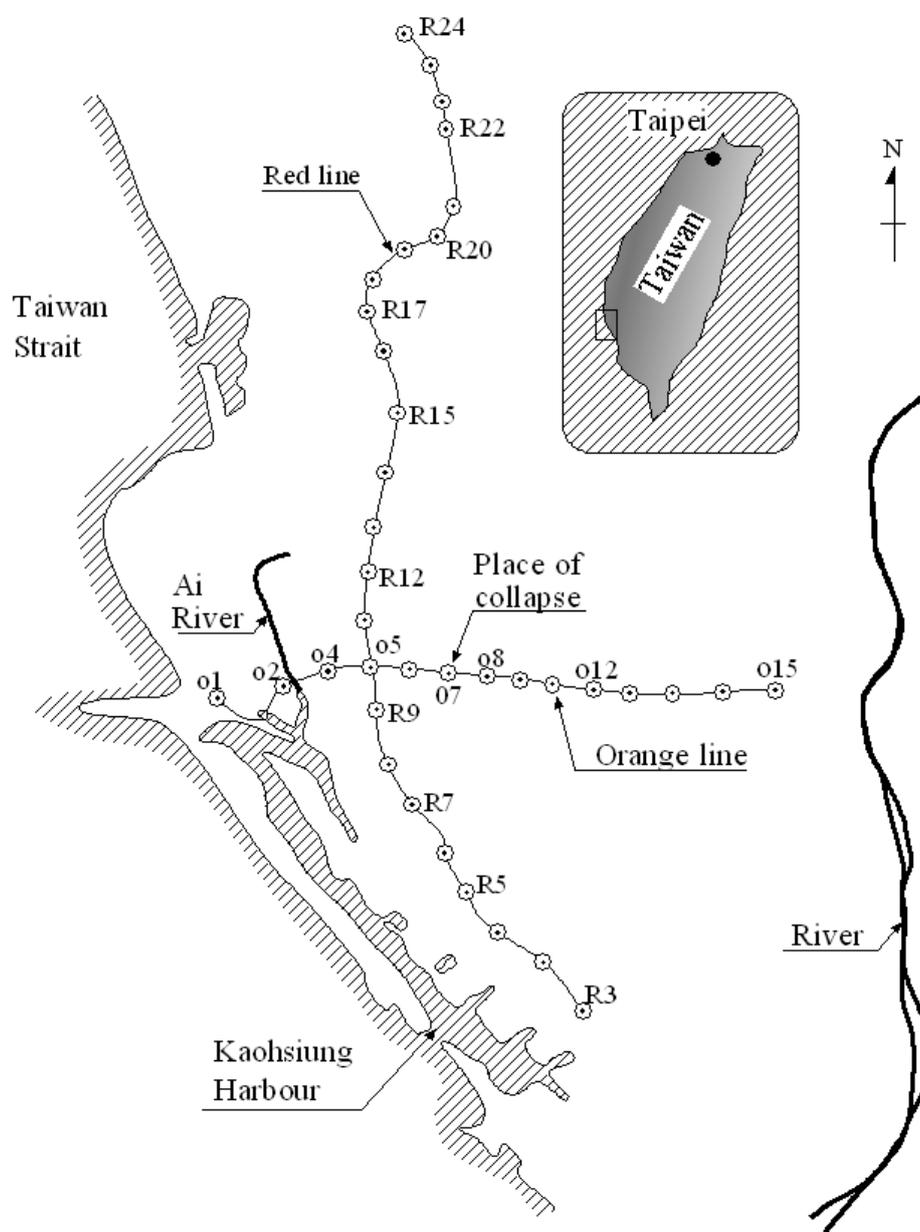
Figure 21. The location of the collapse

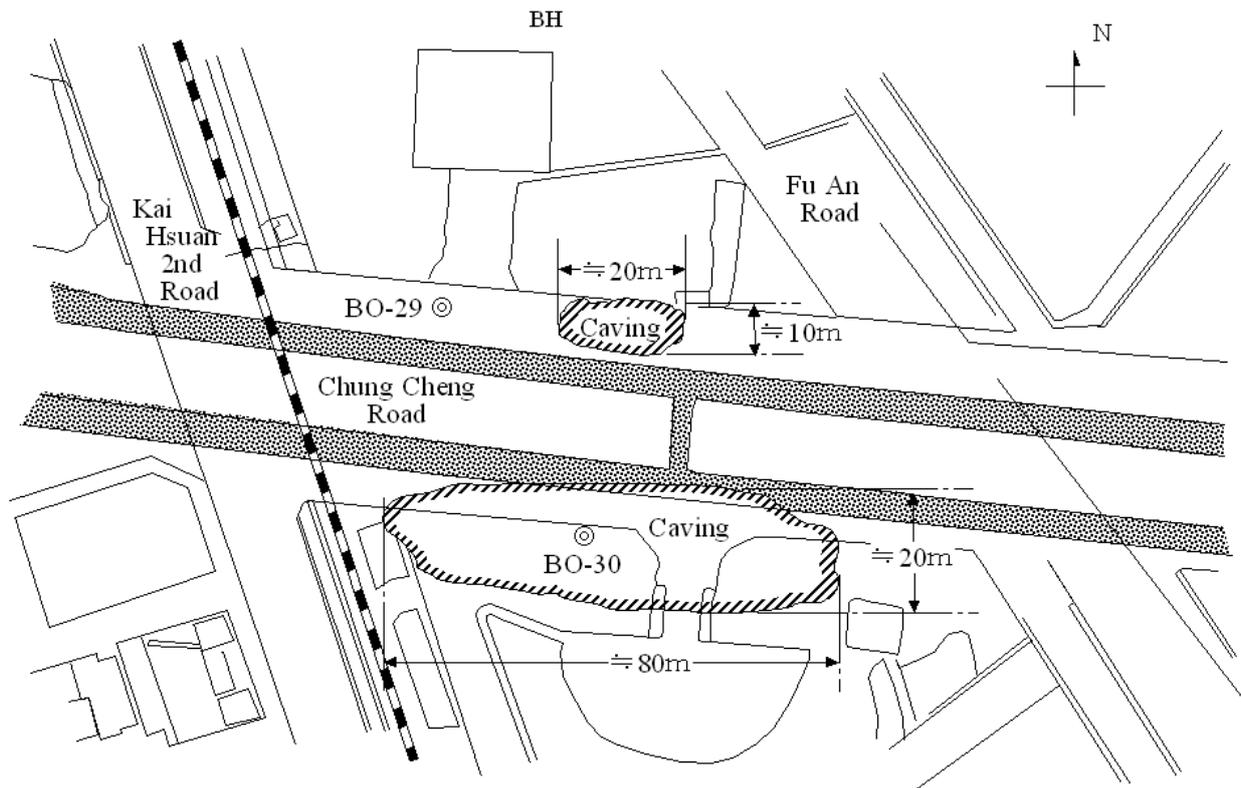
Figure 22. Features of the cave-in in plan view

The soil profiles at the locations BO29 and BO30 shown in Figure 22 are indicated in Figure 25, where it can be seen that the deposits are comprised predominantly of silty sand with occasional layers of low-plasticity clay (CL) to a depth of 40m. The blow count, N-value, in the standard penetration test is shown to increase with depth and to have a value of 20 to 30 at the depth where the sump for water collection was excavated.

side, as seen in Figure 22. The amount of soils and concrete dumped to fill the caves was $12,000\text{m}^3$ and the volume of water inflow from the 60cm diameter water main lasting about 18 hours until 11:50 p.m. next day was approximately $2,000\text{m}^3$. Thus the total amount of debris was as much as $14,000\text{m}^3$.

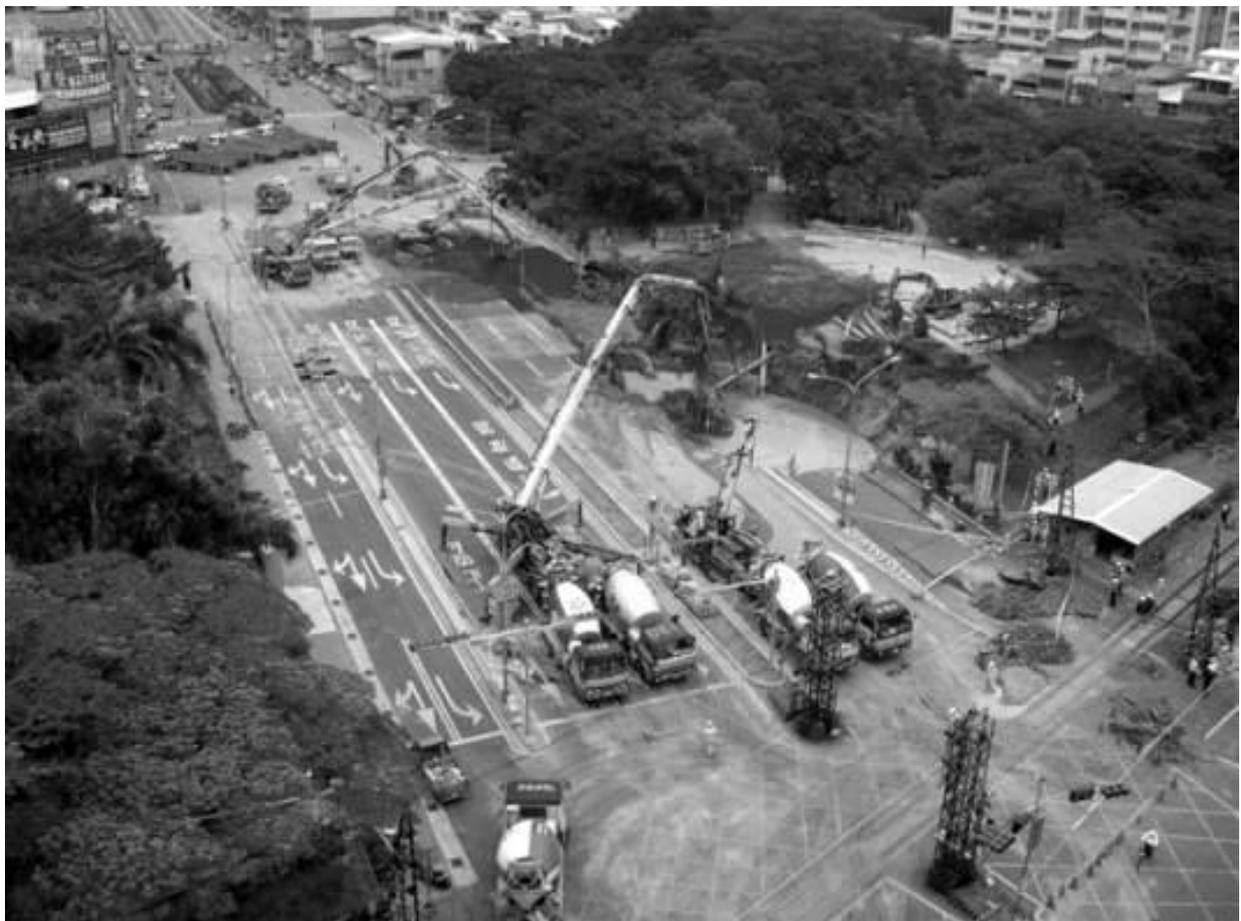
Figure 23. A bird-eye views over the cave-in in Kaohsiung

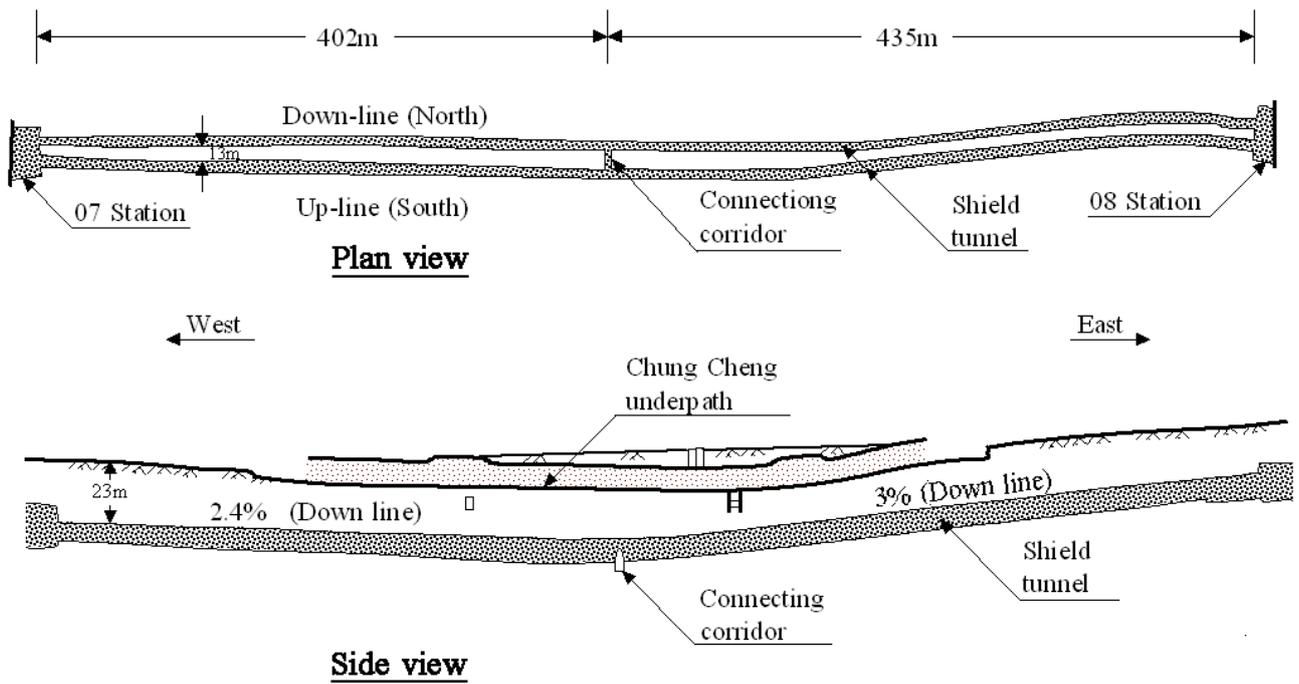
Figure 24. Plan and side view of the tunnel

and side view of the tunnel are shown in Figure 24. It is to be noted that there was an underground roadway called Chung Cheng under path just above the subway tunnel. The dual tunnels were constructed by the tunnel boring machine (TBM) which can advance by rotating a large steel disk equipped with cutting blade, while the cutting face is balanced by the mud pressure.

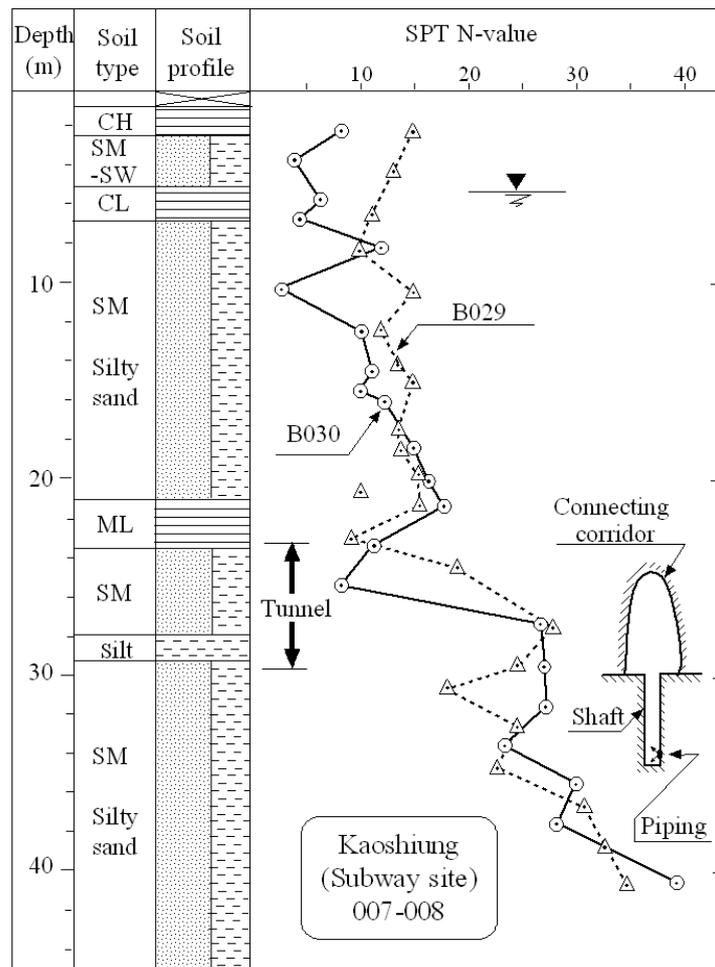
Figure 25. Soil profile at the site of collapse

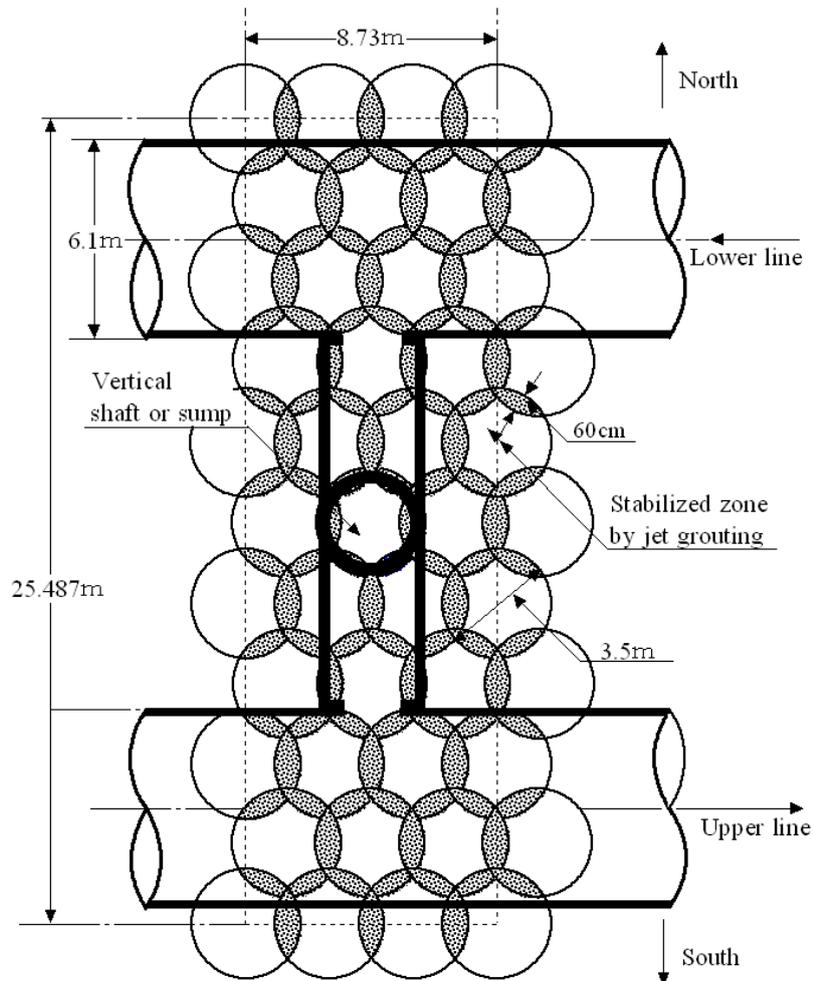
Figure 26. Plan view at the top of the stabilized zone (El. 85.83m)

The arrangement of the stabilized soil columns in plan view at an elevation of 85.83m (zero point is taken at a depth 100m below the median sea level) or at the depth of 31m is shown in Figure 26. It may be seen that each column was installed so as to have mutual overlapping of 60cm and to produce a huge stabilized massive zone 8.73m by 25.487m in plan which was considered strong and competent enough to permit excavation of the connecting corridor and the sump to be carried out in dry open conditions without any distress.

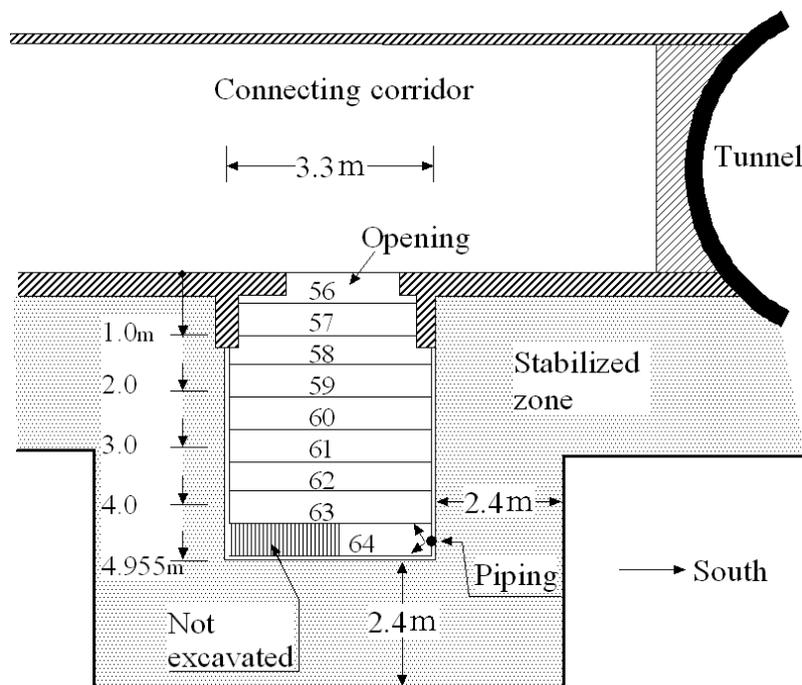
Figure 27. Details of the excavation for the sump and initiation of piping

On December 4, 2005, the piping occurred at 3:30p.m. at the very last stage of excavation of the sump. A block of silty sand was detached from the south wall at the bottom of the excavation which is located at a depth of 35m from the ground surface. The circumstance at this time at the bottom of the sump excavation is illustrated in details in Figure 27.

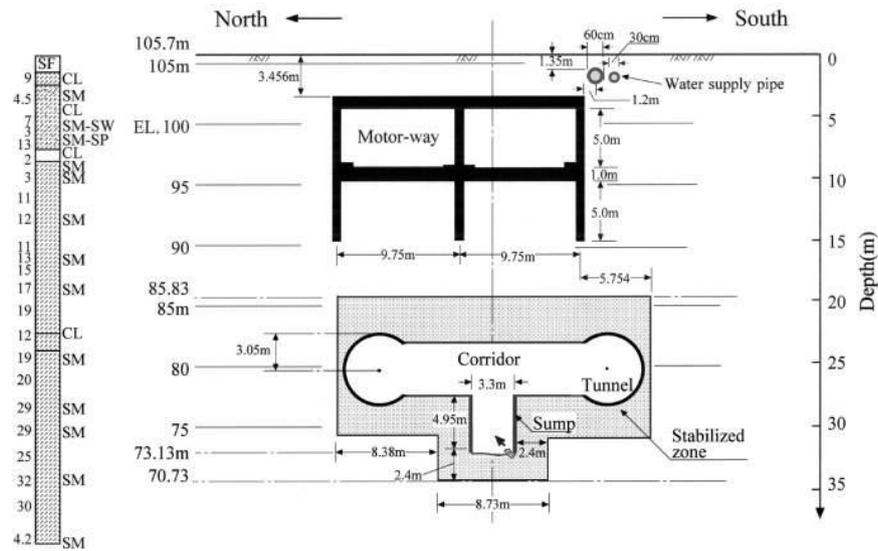
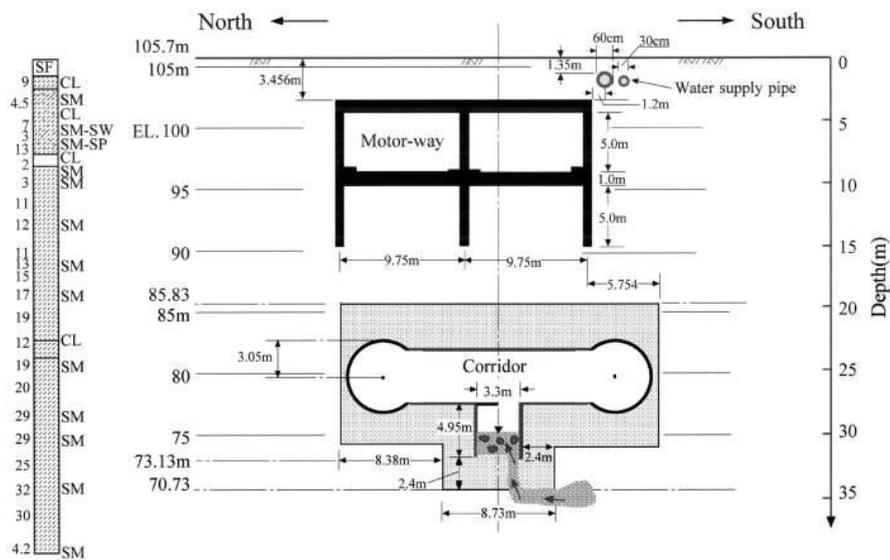
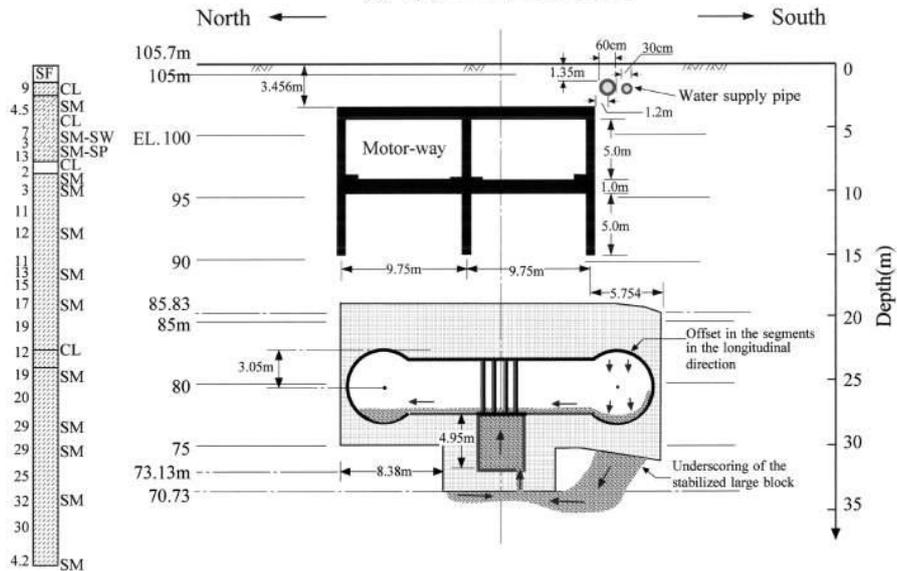
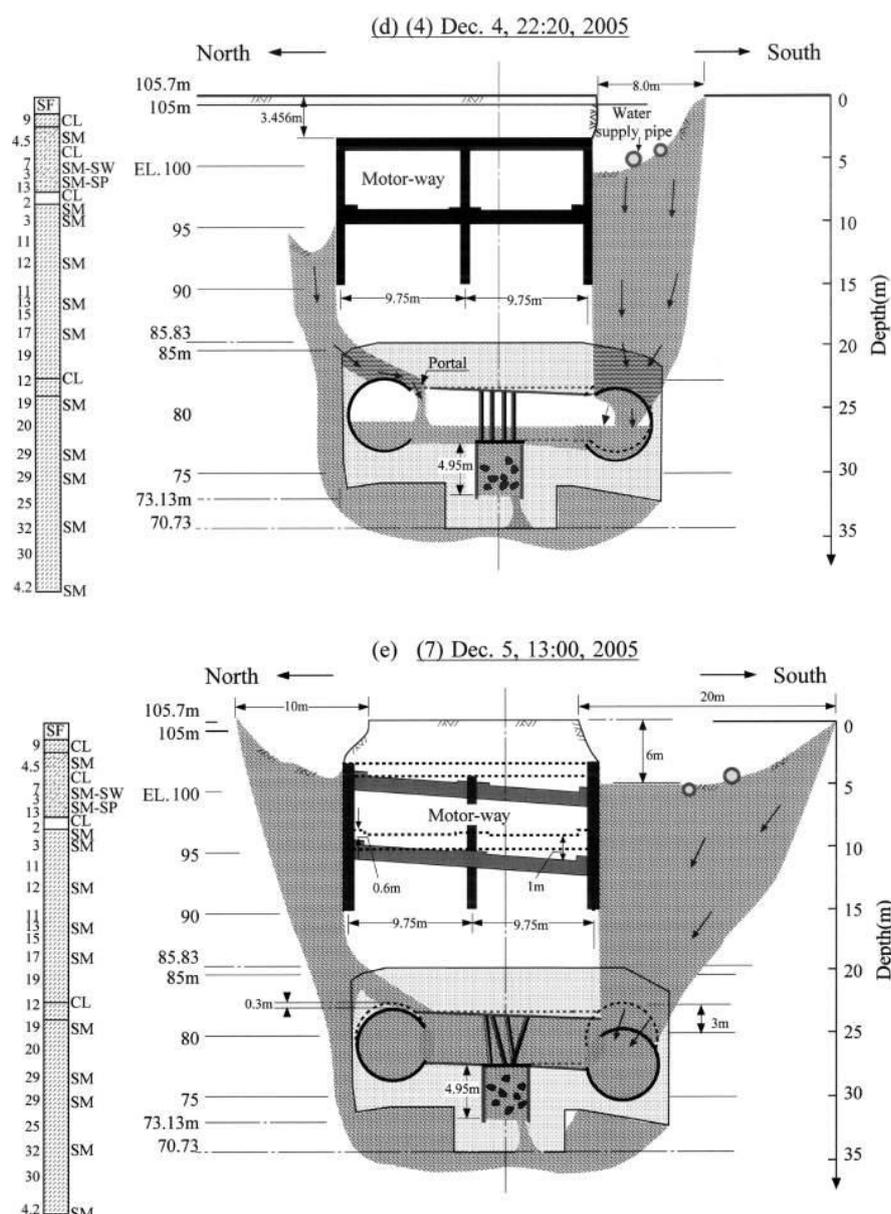
(a) (1) Dec. 4, 15:30, 2005

(b) (2) Dec. 4, 16:15, 2005

(c) (3) Dec. 4, 17:30, 2005

Figure 28. A sequence of likely scenario for progressing the piping failure

A sequence of the events after triggering the piping which are likely to have occurred is illustrated in the cross sections in Figure 28. The blackish mud water continued to come out in the sump with increasing volume. Two men at work at the bottom strove in vein to clog the hole by dumping sand bags from the corridor. About one hour later, the sand bags were seen moving around in the sump as illustrated in Figure 28 (b). At this stage, the workmen closed the entrance to the sump by placing a steel lid and several bars for its support as illustrated in Figure 28 (c).

About two hours later, engineers at spot heard squeaking sounds of breaks at segment joints of the tunnel on the south, accompanied by mud water cascading from the ripped joints of segments at the ceiling. It appears likely that because of the underscoring of the bottom portion, the stabilized zone subsided together with the tunnel body, resulting in the stepwise settlement in the longitudinal direction. The probable feature of the breakage at this stage is illustrated in Figure 28 (c).

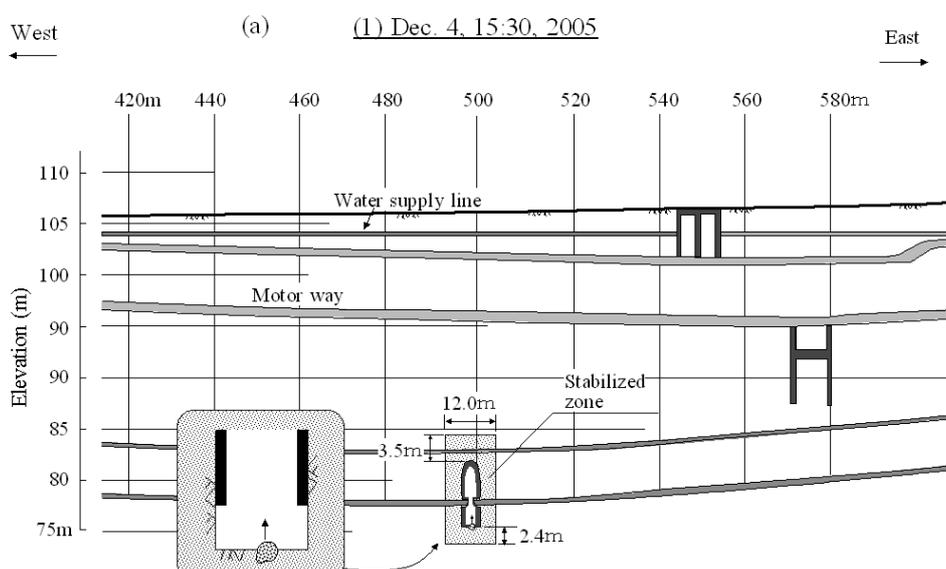
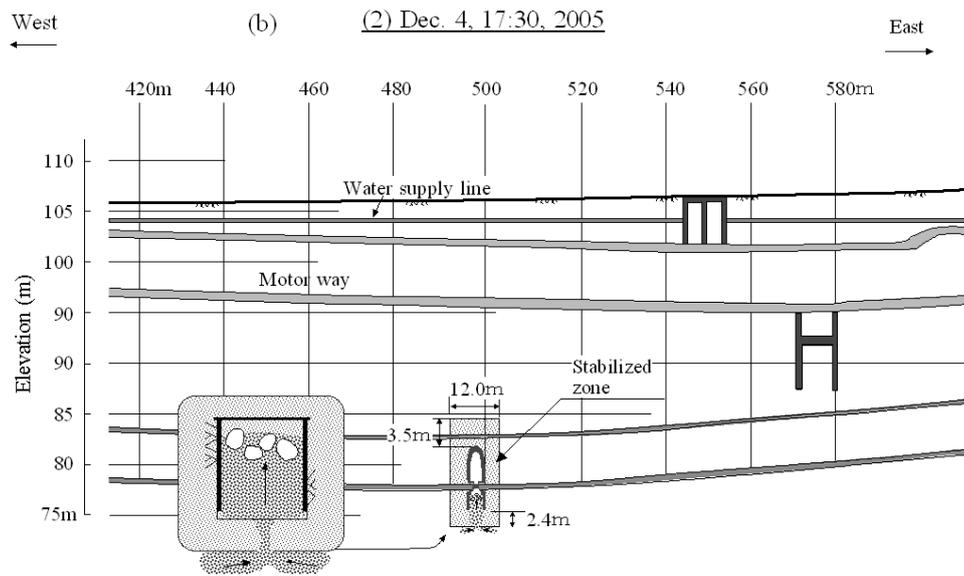
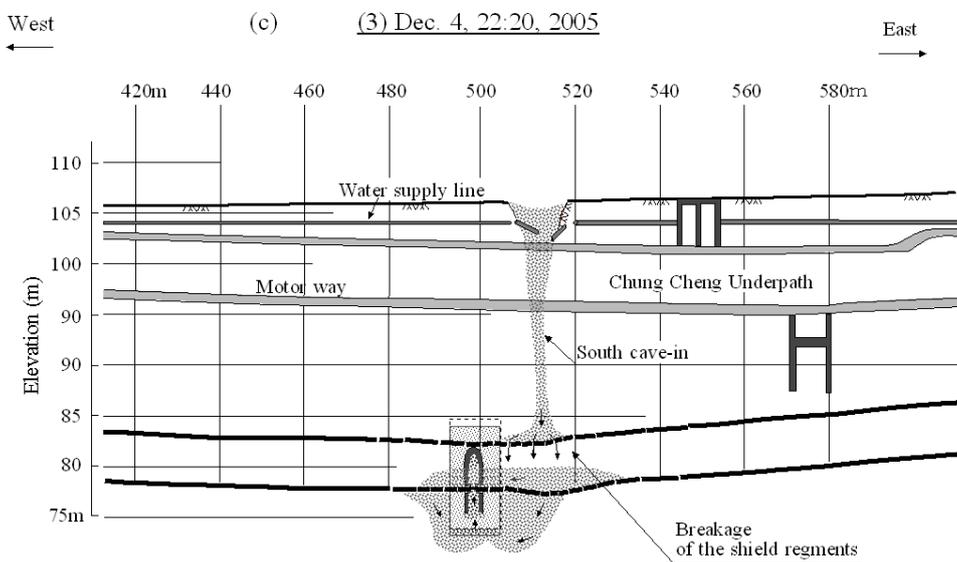
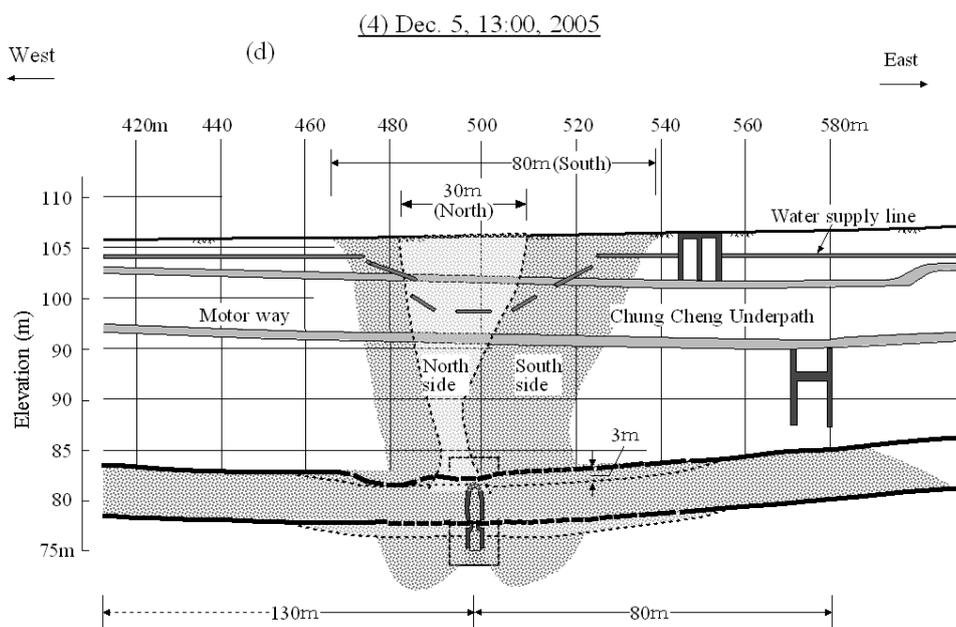
Figure 29. A sequence of likely scenario in the longitudinal direction

The feature of the collapse propagation as above would be understood more vividly by visualizing the sequence of events that might have occurred in the longitudinal direction. These features are described in Figure 29(a) through 29(d). Figure 29(c) and 29(b) shows the progress of the collapse from 3:30p.m. to 5:30p.m. on December 4, 2005. Figure 29(c) indicates the breakage of the tunnel, segment by segment, resulting in the fall-off the debris from the offsets of the segments in the ceiling on the east side. On the north side undermining of the tunnel body did occur as well as shown in Figure 28(d), resulting in the sinking of the tunnel together with the large block of the stabilized zone. This led to the breakage of the segment joints on the north side and allows the mud water cascading mainly through the opening at the junction between the portal and the adjacent segment. The length of the tunnel in which the debris packed in the entire cross section was as long as 130m on the west side and 80m on the east side in the up-line on the south, as shown in Figure 29(d). Thus, another cave-in occurred on the north

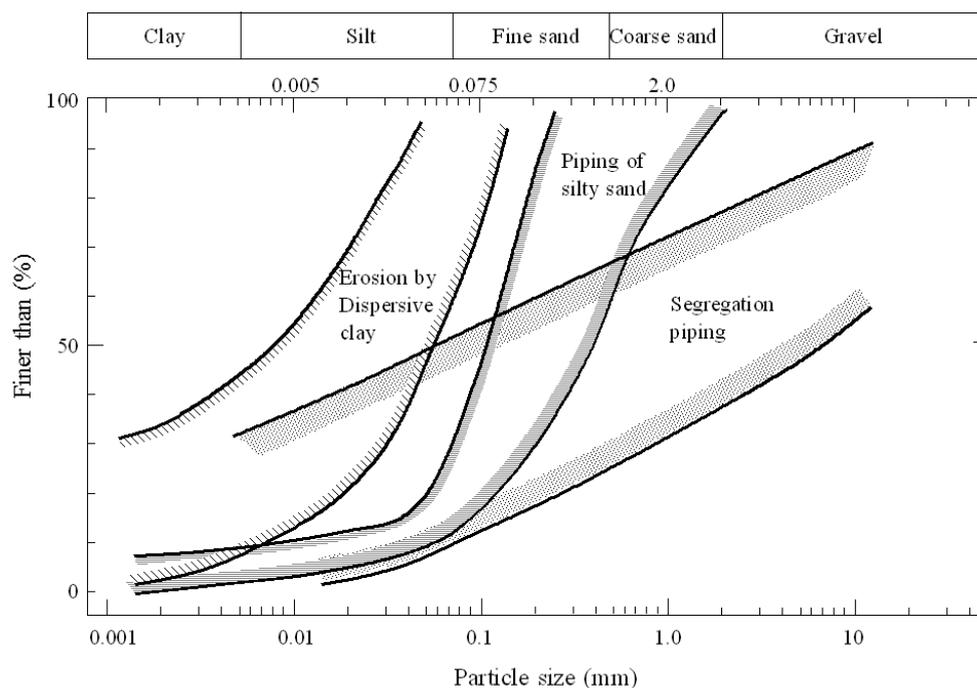
Figure 30. Three groups of soils in terms of grain size range associated with erosion and seepage instability

With respect to the piping or erosion, there would be three types of problems to be distinguished depending upon the range of grain size of soil materials in question. These are shown in a graphical form in Figure 30. The segregation piping has been the target of extensive studies in the past in association with the filter criteria for the design of rock fill dams. There are many studies reported in this context such as those by Terzaghi (1939), Kenny-Lau (1985, 1980), Skempton-Brogan (1994) and Sherad (1979).

The outcome of the grain-size analyses for the silty sand at Kaohsiung has shown that the soil there belongs neither to the broadly graded gravelly sands for the segregation piping nor to the dispersive clay related to the erosion or gully formation. In fact, the grain size in Kaohsiung soil lies midway in the range of silt and sand, as shown in Figure 30, which is coarser than the dispersive clay and finer than the soils related with segregation piping.

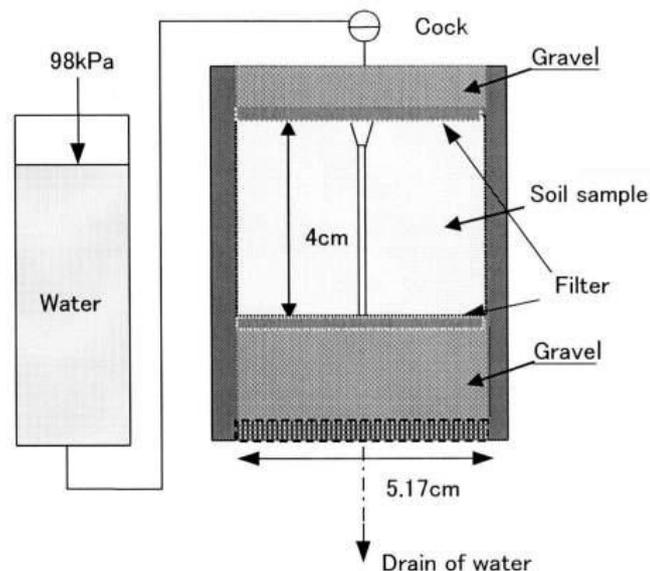
Figure 31. Layout the pinhole test

In order to examine the vulnerability of the silty sands at Kaohsiung to the internal erosion or piping, what might be called “Pinhole test” was carried out. The layout of the test system is displayed in Figure 31. The sample 4cm thick and 5.17cm in diameter was sandwiched by highly pervious gravel layers at the top and bottom with filter meshes placed between the sample and gravel. A vertical hole 3mm in diameter was drilled as shown in Figure 31. Water was then circulated through the sample. In this type of test, water is supposed to flow mainly through the pinhole. If the silty portion is erodible, the water coming out is expected to be muddy, but otherwise the water transparent.

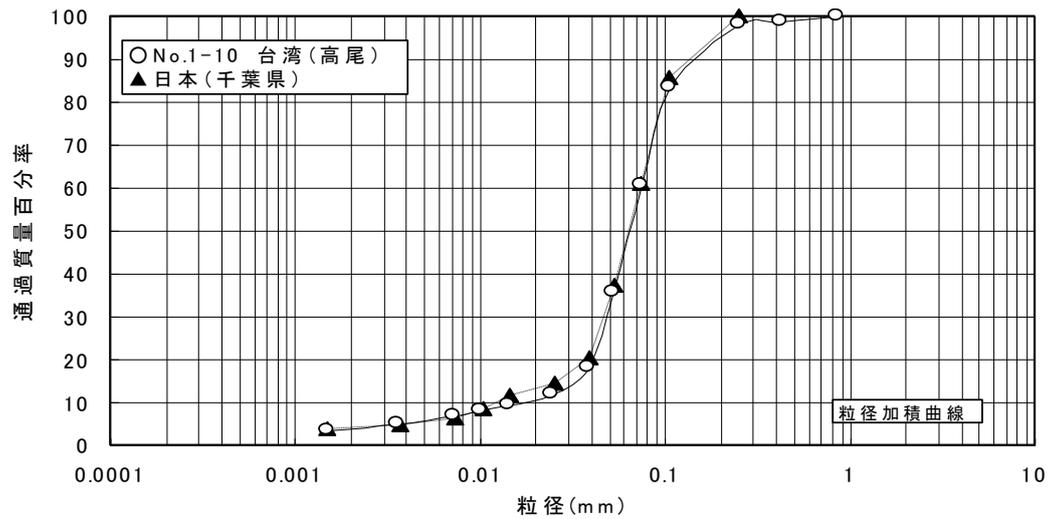
Figure 32. Grain size distribution curves of silty sands used for the pinhole tests

The silty sand from Kaohsiung tested had a grain size distribution as shown in Figure 32. For comparison sake, another material from a site in Chiba, Japan was secured and used for the same testing. The grading of this Japanese soil was almost the same as indicated in Figure 32. It is to be noticed that both silty sands had an average grain size of about $D_{50}=0.075\text{mm}$ and fines content was about 50%. The physical characteristics of these two materials are shown in Table 1. The two samples were compacted so as to have the same wet density of 1.902 g/cm^3 . A sample from Kaohsiung as pre-prepared for the pinhole test is displayed in the middle of Figure 33 and gravel layers to be placed on top and at the bottom are shown on both sides of Figure 33. The procedures for testing were as follows.

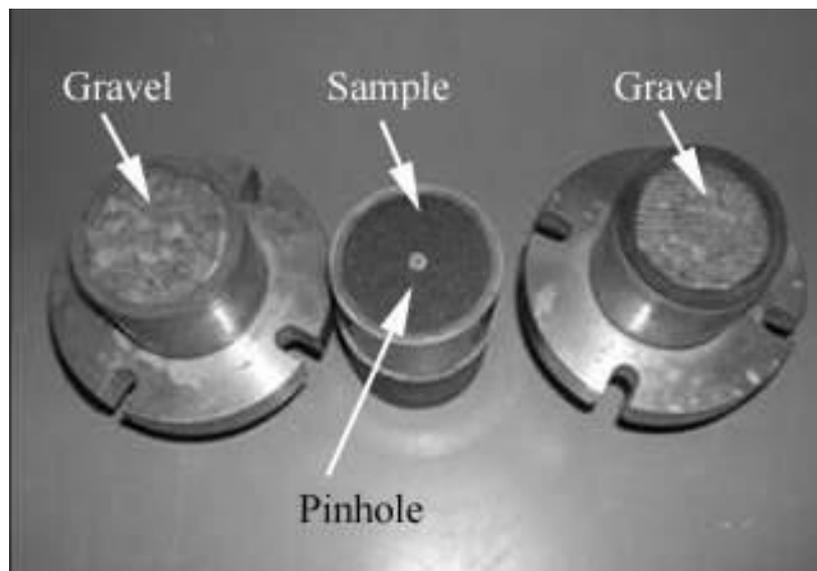
Figure 33. A samples from Kaohsiung for the pinhole test (the middle)

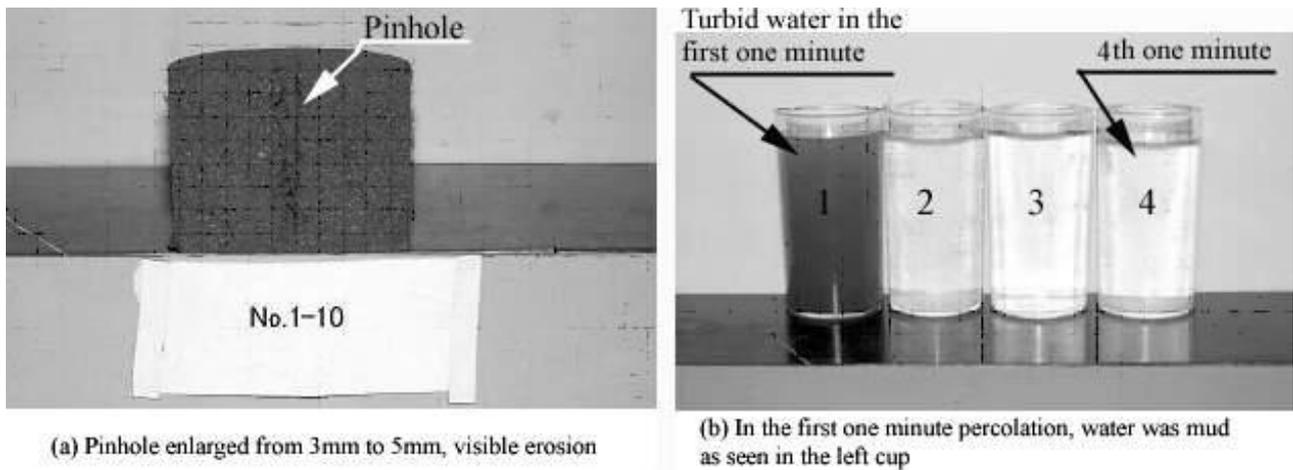
Figure 34. Silt-contained sample from Kaohsiung

In the first series, the tests were conducted on disturbed samples, one from Kaohsiung and another from Japan. The result of the pinhole tests on a disturbed sample is presented in Figure 34. For the disturbed silt-containing sand sample from Kaohsiung, the pinhole is seen enlarging to a diameter of 5mm from 3mm as displayed in Figure 34(a). Correspondingly, the drained water from the bottom was muddy for the first one-minute period of water percolation as seen in the water colour in the left-side cup of Figure 34(b). The result of the pinhole test on the Japanese silty sand is shown in Figure 35. In contrast to the Kaohsiung soil, the circulation of water through the Japanese soil did not exhibit any appreciable change in colour in the first one minute of percolation as seen in Figure 35(b). There was no change in the pinhole diameter for the Japanese soil before and after water permeation except for a local collapse at the top. Thus, it may be conclusively mentioned that the silty sand from Kaohsiung is potentially susceptible to internal erosion as compared to the soil from Chiba, Japan, although they had al-most the same grading. This is believed to stem from the highly non-plastic nature of the Kaohsiung silt contained in the sand.

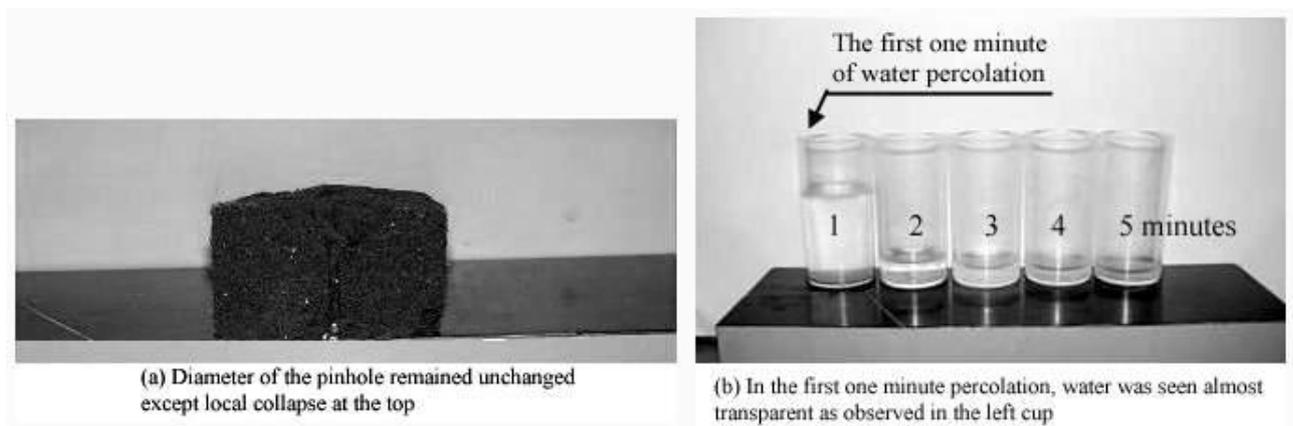
Figure 35. The results of the pinhole test on the Japanese silty sand

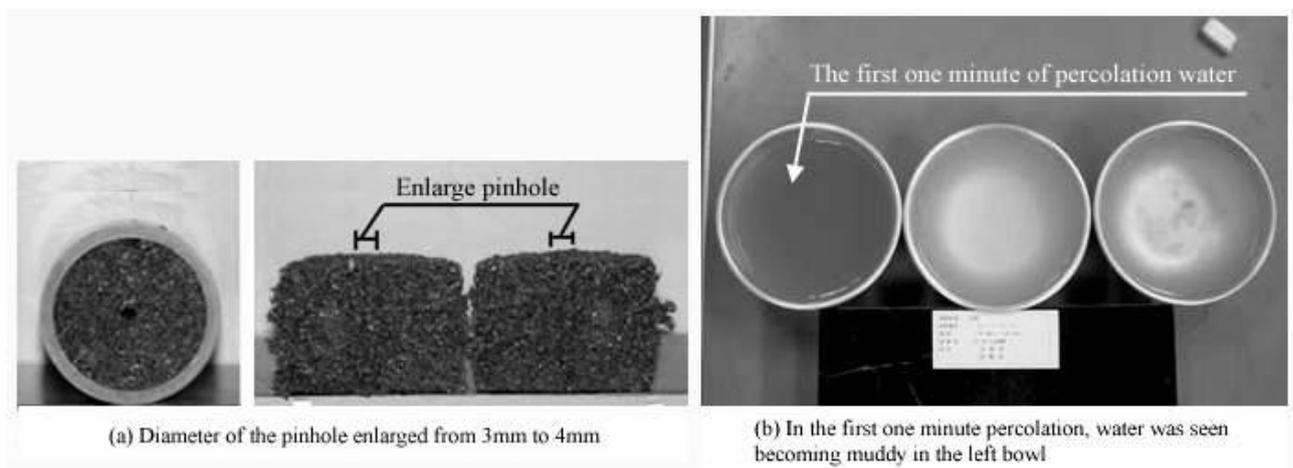
Figure 36. Pinhole tests on undisturbed samples from Kaohsiung

In the subsequent series, similar pinhole tests were conducted on undisturbed samples. The undisturbed sample from the depth of 14m in Kaohsiung also demonstrated dirty blown colour in the first one-minute of percolation accompanied by the enlargement of the pinhole from 3 to 4mm, as displayed in Figure 36. Two fine sand samples from a deposit at depth 22m in Kaohsiung were tested likewise with the result that it is also vulnerable to internal erosion. From the series of the pinhole tests as described above, it may be concluded that, no matter whether the soil is disturbed or undisturbed, the silt ingredient contained in the Kaohsiung sand is not only non-plastic but also highly erodible being susceptible to piping as compared to other silts with the same gradation such as those in Japan.

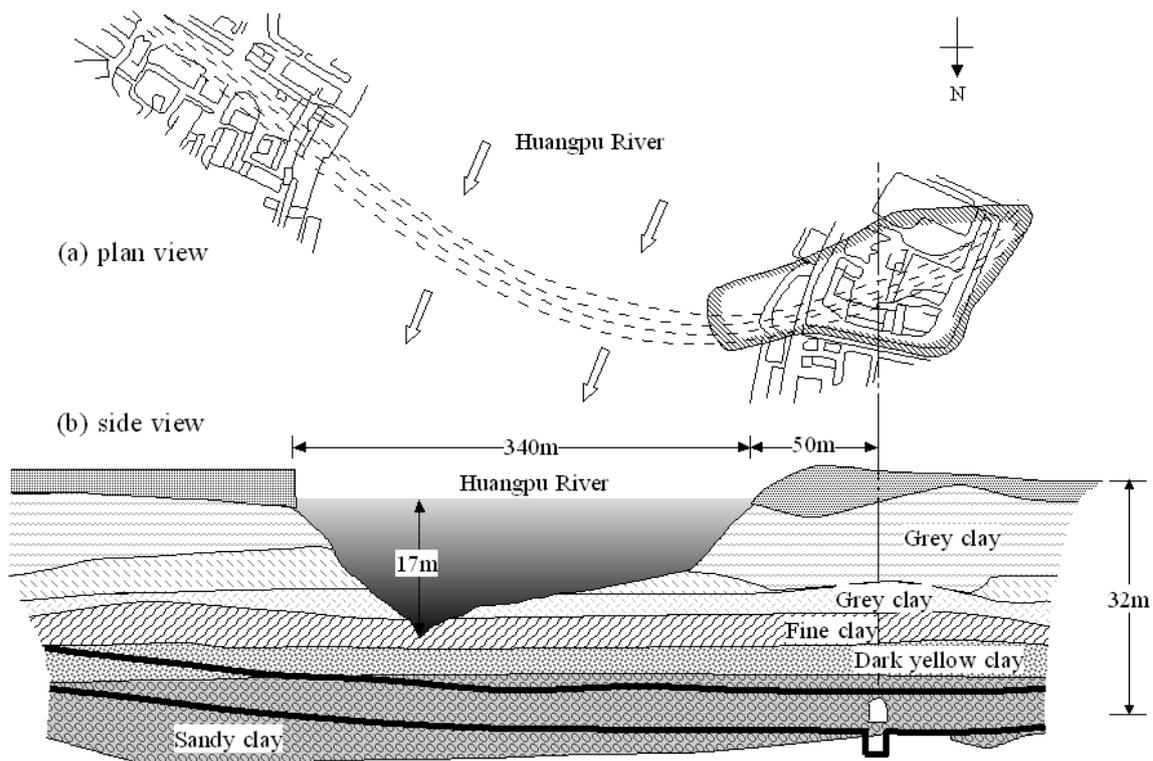
Figure 39. Plan and side views of the tunnel across the Huangpu River

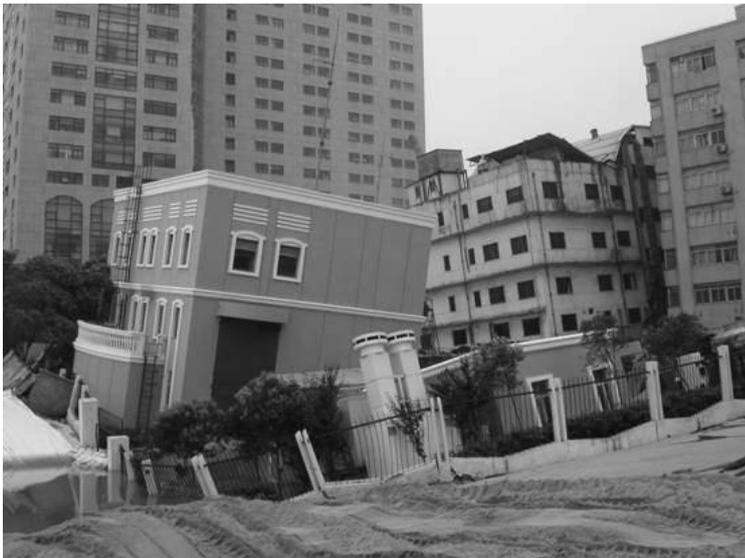
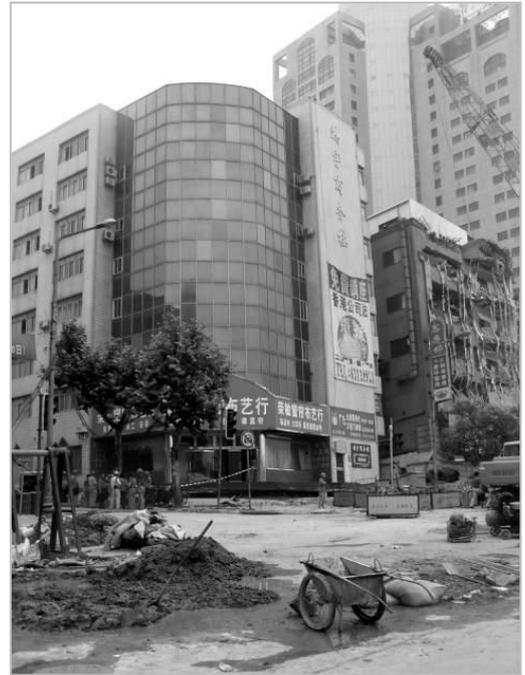
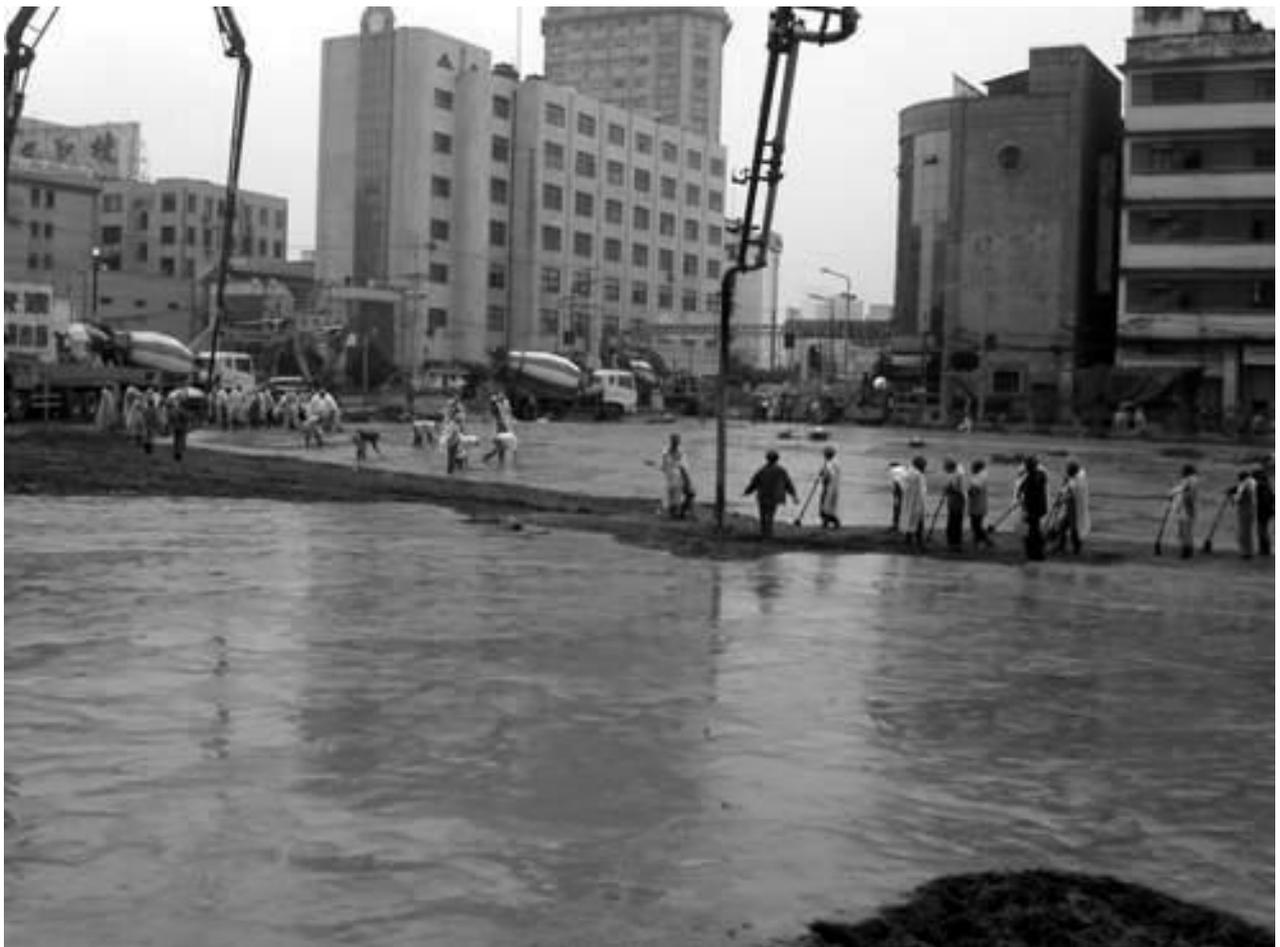
(a) Sinking and tilting of buildings in the area of the ground subsidence

(b) Tilting of nearby building

(c) Flooding due to breach of the river dike

Figure 40. Damage by ground settlement due to underground collapse in underground excavation, Shanghai

A large-scale collapse took place on July 1, 2003 in the south part of Shanghai at a site where a new No.4 line of subway was under construction, leading to a large cave-in and subsidence of the ground. The location of the city near the mouth of Yangzu River is shown in Figure 35. As indicated in a more de-tailed map in Figure 38, the incident occurred at the location on the west bank of the Huangpu River. As shown in Figure 39(a), the curved sections across the river had been constructed by means of the mud-type shield tunneling machine. The river channel is 340m wide and 17m deep at this location as indicated in Figure 39(b). As a result of the cave-in, the city area on the west bank, about 70m wide and 150m long, suffered the ground subsidence of the order of 1-2m, as indicated in Figure 39. The settlement extended into the riverbed, thereby involving the sinking of the river dike accompanied by inundation of the river water. Figure 40(a) shows sinking of two buildings in the forward and tilting of 7-10 storey buildings in the back ground. A high-rising building 30 storey high is also seen tilting in the back ground of Figure 40(b). Figure 40(c) shows the flooding in the city by inundation of water from the river.

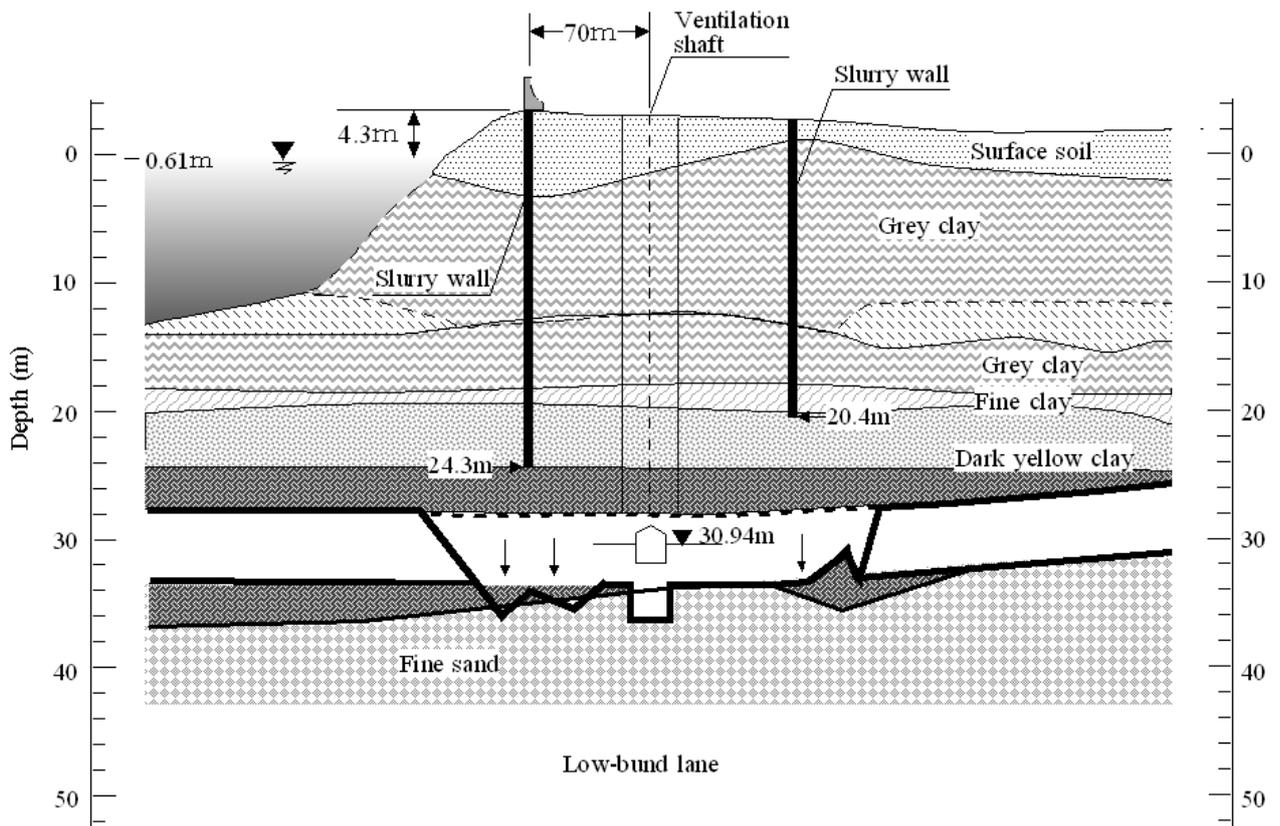
Figure 40. Cross section along the subway line showing the feature of the collapse
