The Eighteenth Spencer Buchanan Lecture
Friday December 3, 2010
College Station Hilton
College Station, Texas, USA
<http://ceprofs.tamu.edu/briaud/buchanan.htm>

Uncertain Geotechnical
Truth and Cost Effective
High-Rise Foundation
Design

The 2009 Karl Terzaghi Lecture
By Mr. Clyde Baker

Forensic Diagnosis for
Site-Specific Ground
Conditions in Deep
Excavations of Subway
Constructions

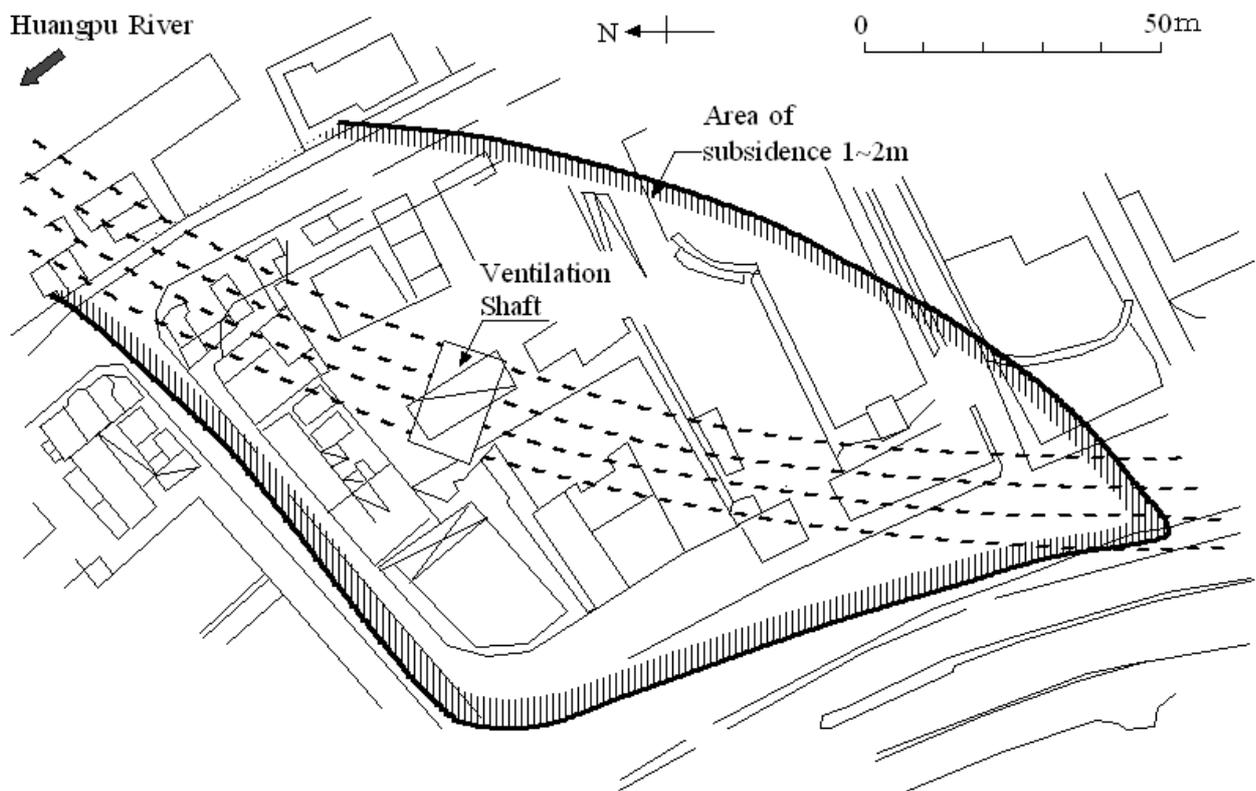
Figure 42. City area of the ground subsidence on the west bank of the Huangpu River
